## Project Info

29 May 2021

Lonavala, MH

Tata Power, India

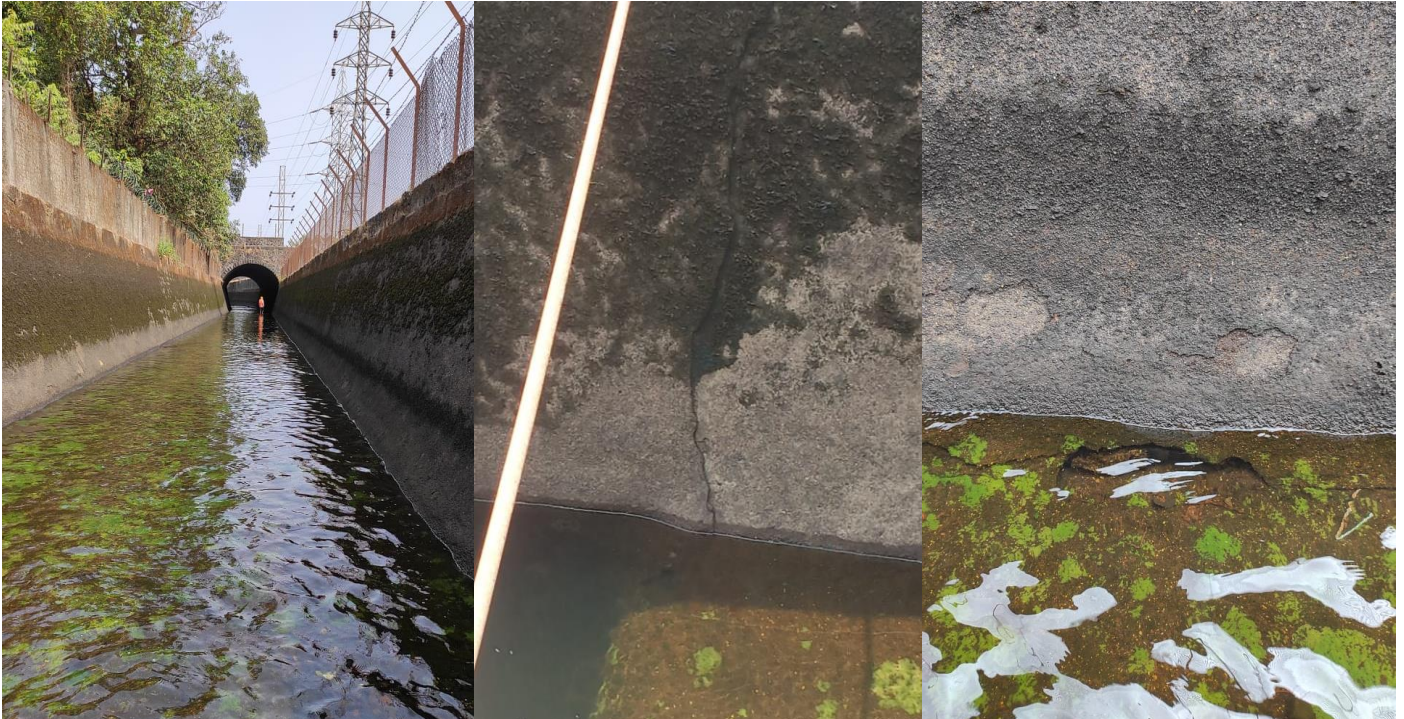
Photos Pain point of duct line showing cracked & eroded concrete lining

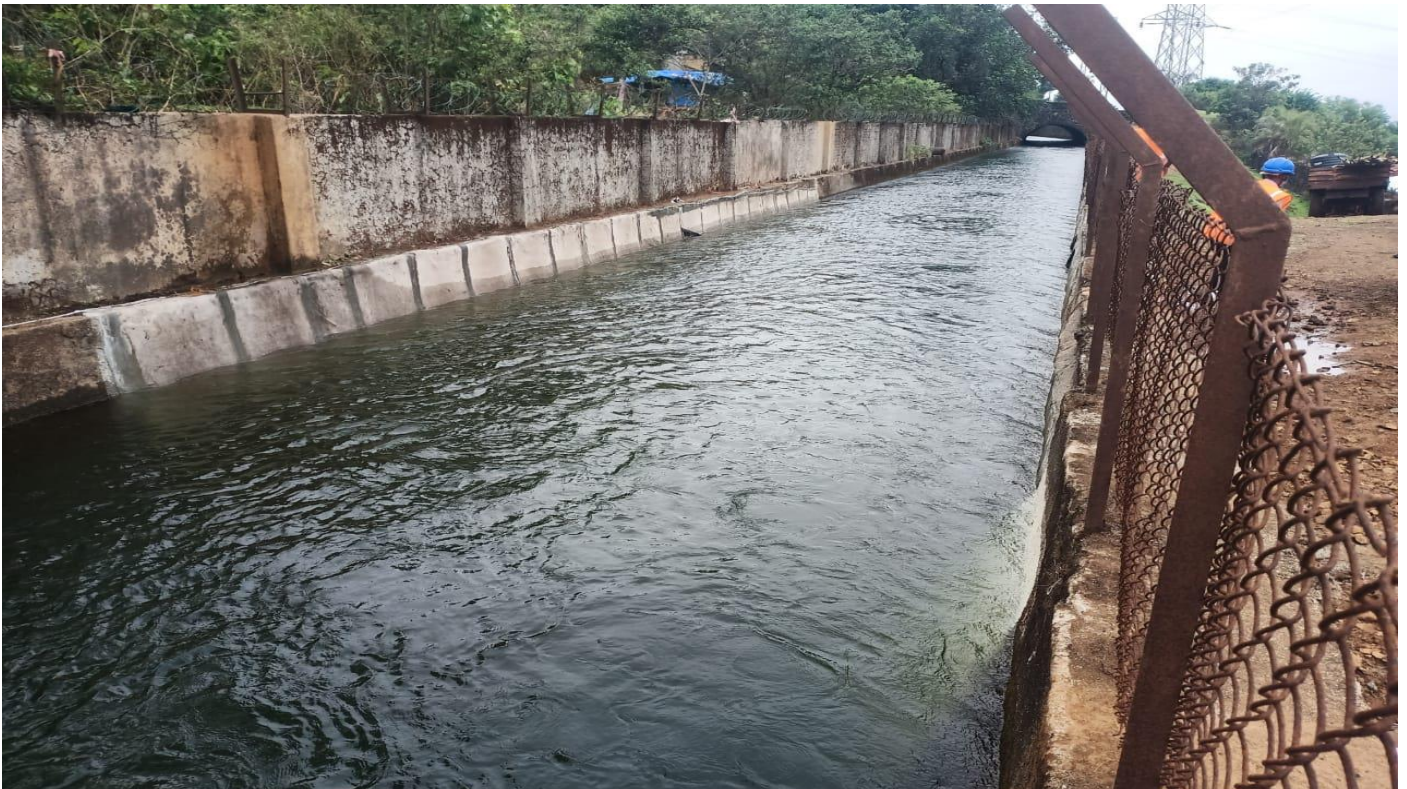
*Full Supply Level after installation done in duct line*
