Project Info

CC5™

Vijaywada

A.S. Infrastructures

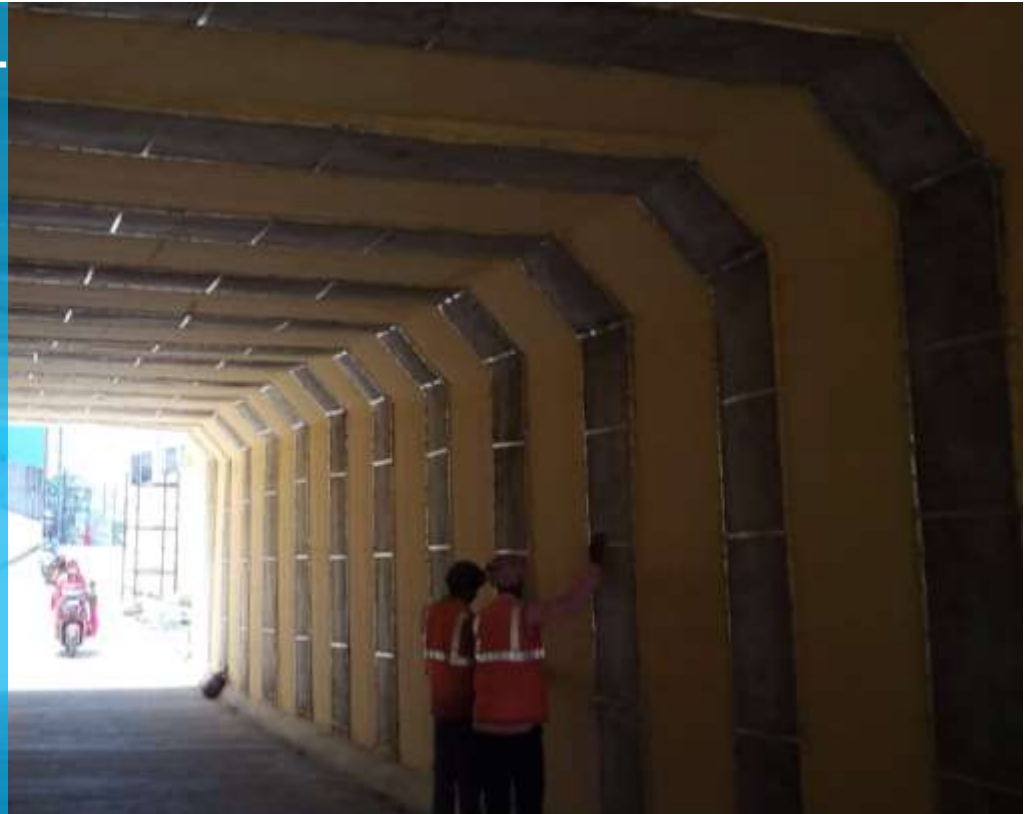
Completed Installation

On March 2021, we have started the work covering the LHS joints from inner side to stop water leakages to the subway. In rainy season, water was percolating through the gaps, which needs to be treated. RVNL Vijaywada allotted this work for covering joints with Concrete canvas to SSPL under A.S. Infrastructures.

The installation team faced challenges like working at the height of 4m from the ground, restricted access and continuous train movements as well as vehicular movements. The silicon sealant used to stick the CC to the LHS blocks were not effective and due to continuous vibrations from rain water movement, we were required to use Hilti nails as well.

In total, 379m² of CC5™ were used to cover 3 LHS ranging from joints of 12-16m internal dimensions of blocks. The team did the first work with some difficulties in only 4 days from start to end. After which the remaining works were done faster due to labors' training. Complete Project was done in 2 weeks' time with 4 engineers and 16 labors' team.

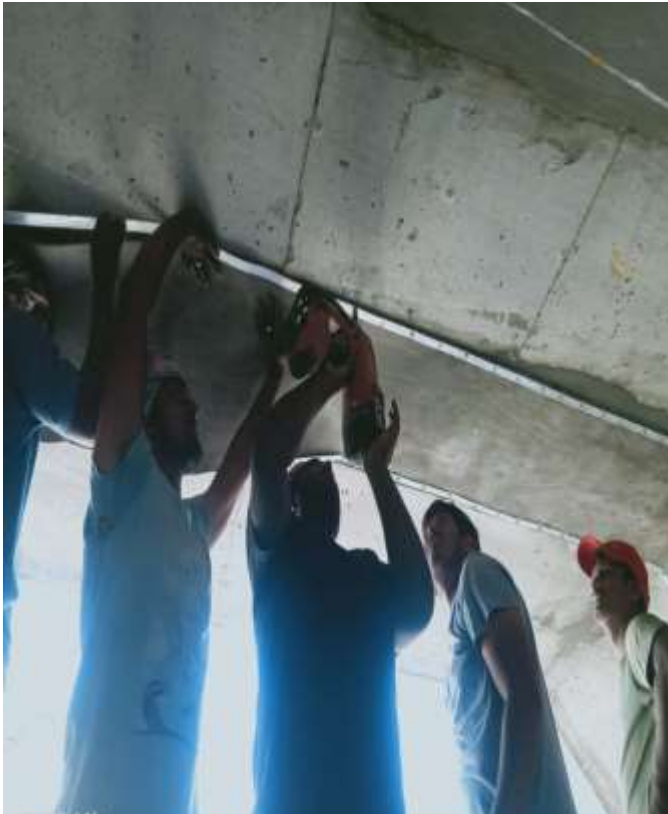
Fixing of top patch with Hilti nailing machine

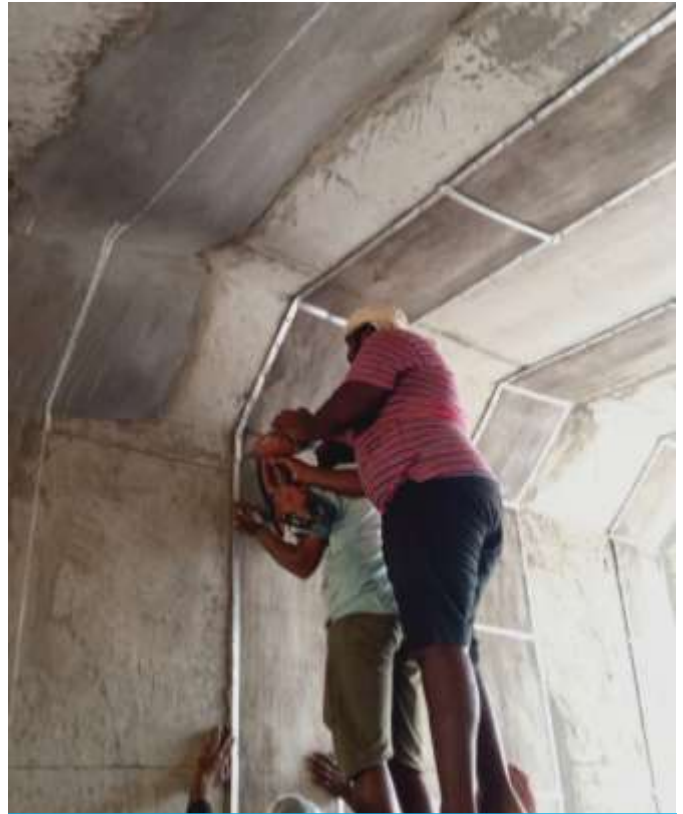
Fixing of vertical patch with Hilti nailing machine

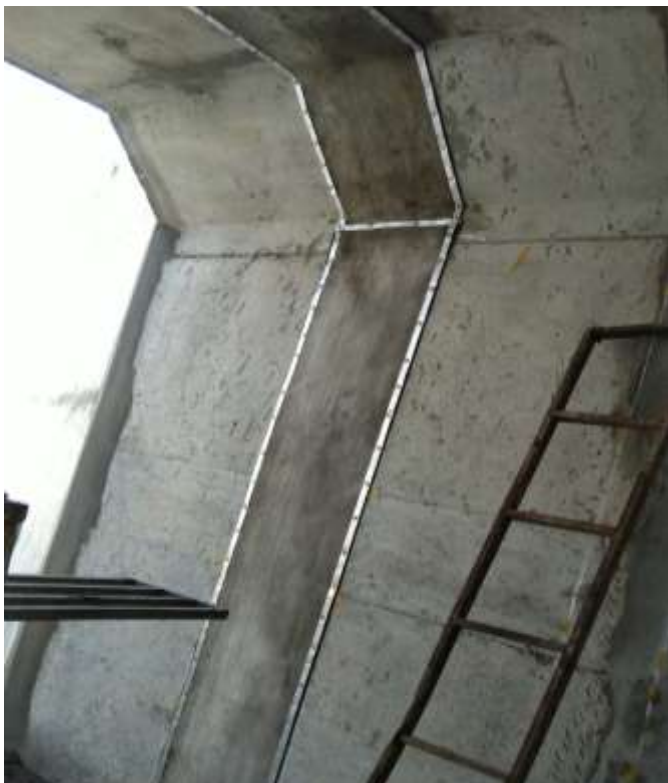
Fixing of vertical patch with Hilti nailing machine

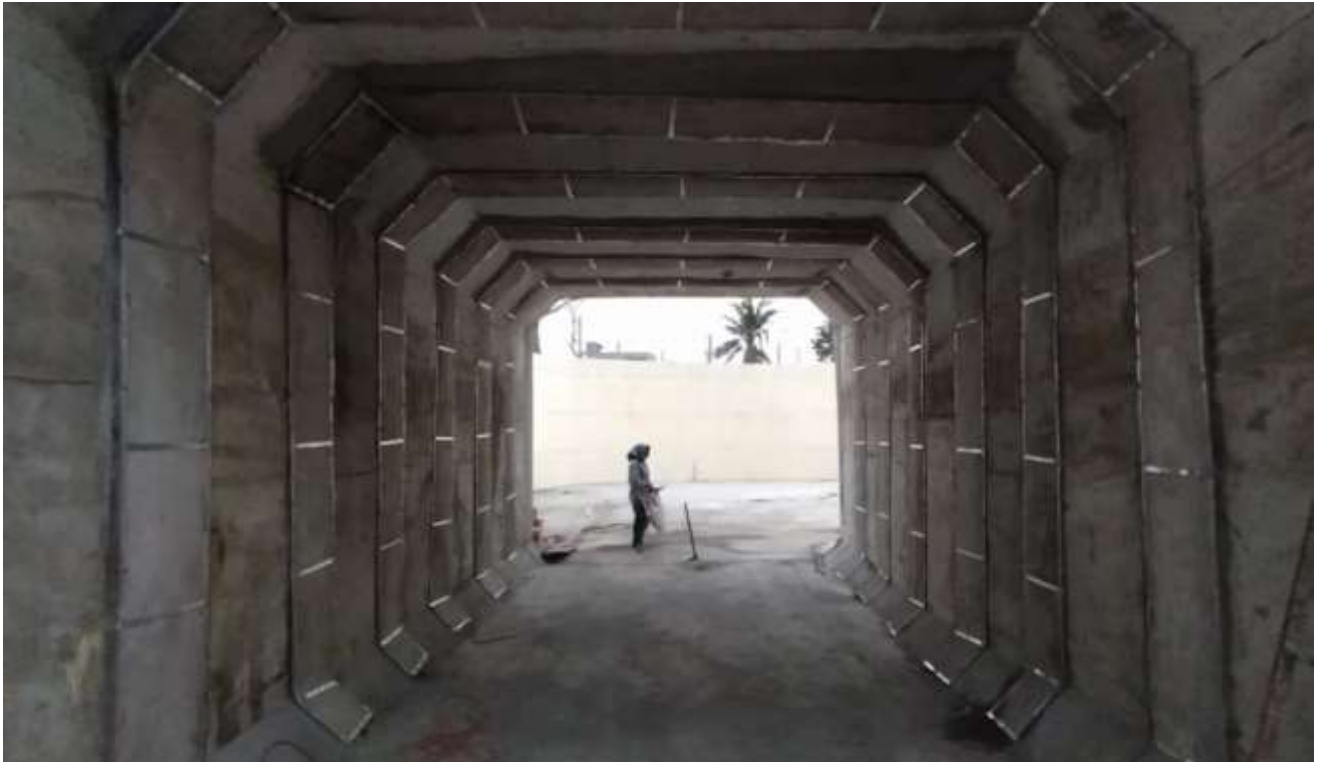
Installation Completed Site

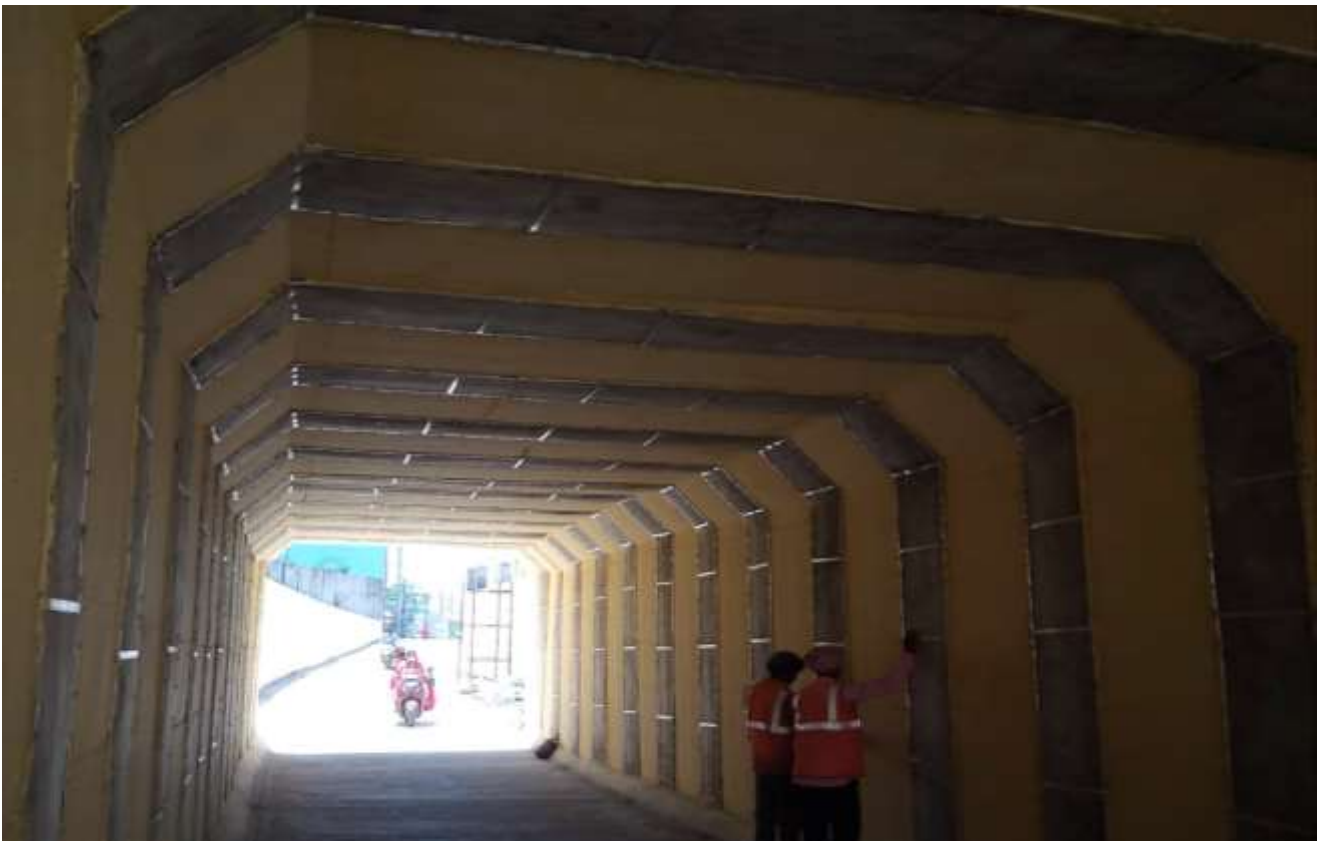
Installation Completed Site
