21 June 2019

Dewdi, Maharashtra

Tata Power Pune

Canal Repair at Dewdi, Mulshi

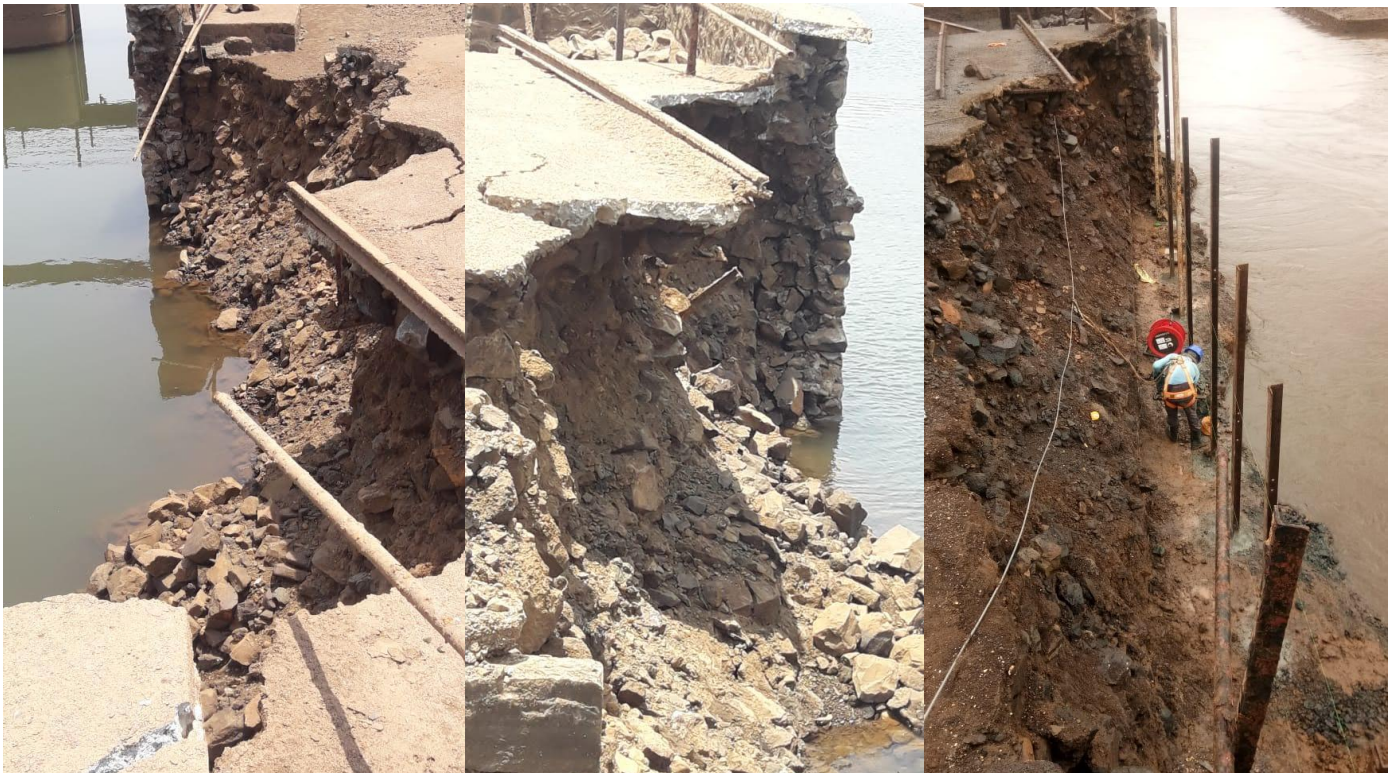
The Major Section of Dewdi Canal was damaged on last week of June 2019 due to seepages and erosion issues in existing old lining. The portion of above 3m in height and 20m collapse suddenly and water starts entering the soil strata immediately, which need to be treated urgently in stipulated time to avoid other issues at canal. The project came with several challenges, including slope cutting, matching uniformity in work, stabilization of slope by placing sand bags, etc.

Side view of Damaged Canal

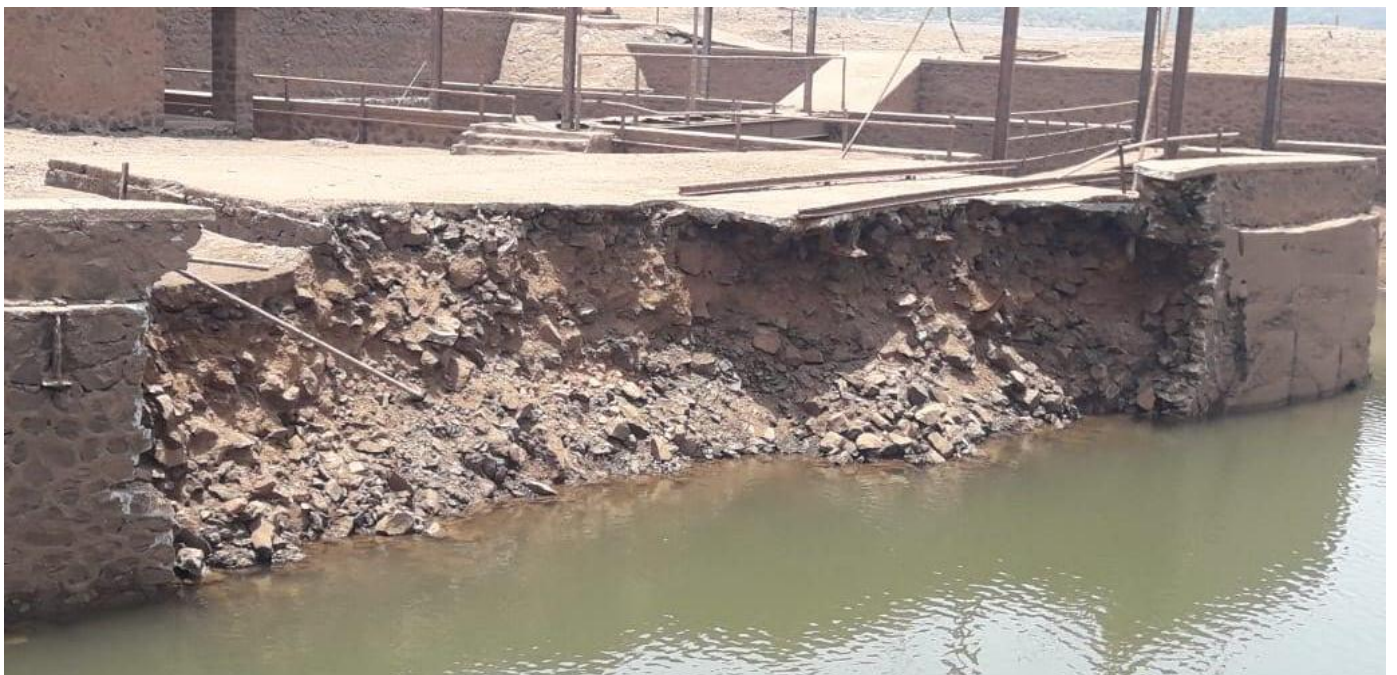
Front view of Damaged Canal

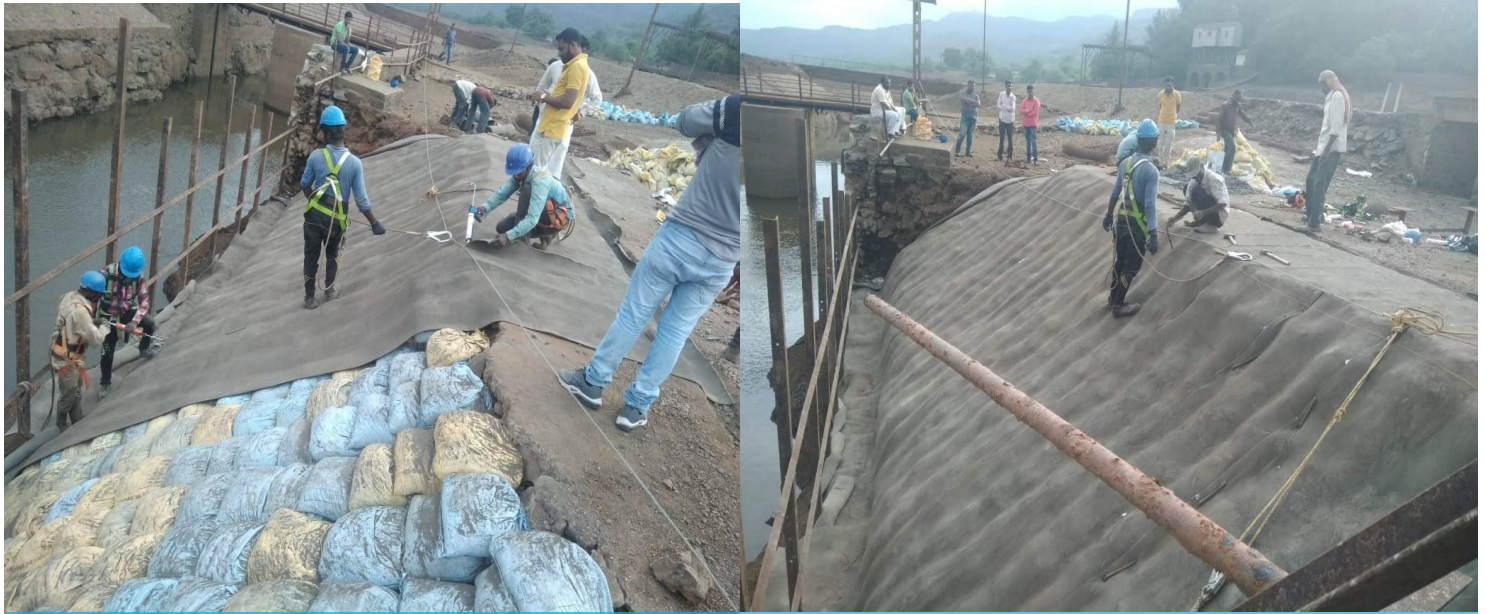
Concrete Canvas Installation

The work required heavy site preparation before actual CC installation. The authorities at Tata Power responded quickly and worked with full efforts to stop further damage and done tremendous job of site preparation as fast as they could. After that Concrete Canvas came in picture for lining the stable slope. Firstly they decided to go for retaining wall but due to the time it will take and in comparison with Concrete Canvas the solution was not so effective. Tata Power has already worked with the product and knows the product well enough to trust it for this type of Canal Repair work.

Total 100sqm of Concrete Canvas 8mm thick was used to repair the canal and difficulties of the client was overcome in only 2 days of work with 15 labours team. The authorities were pleased with the speed and effectiveness of Concrete Canvas and look forward to work on their other projects too.

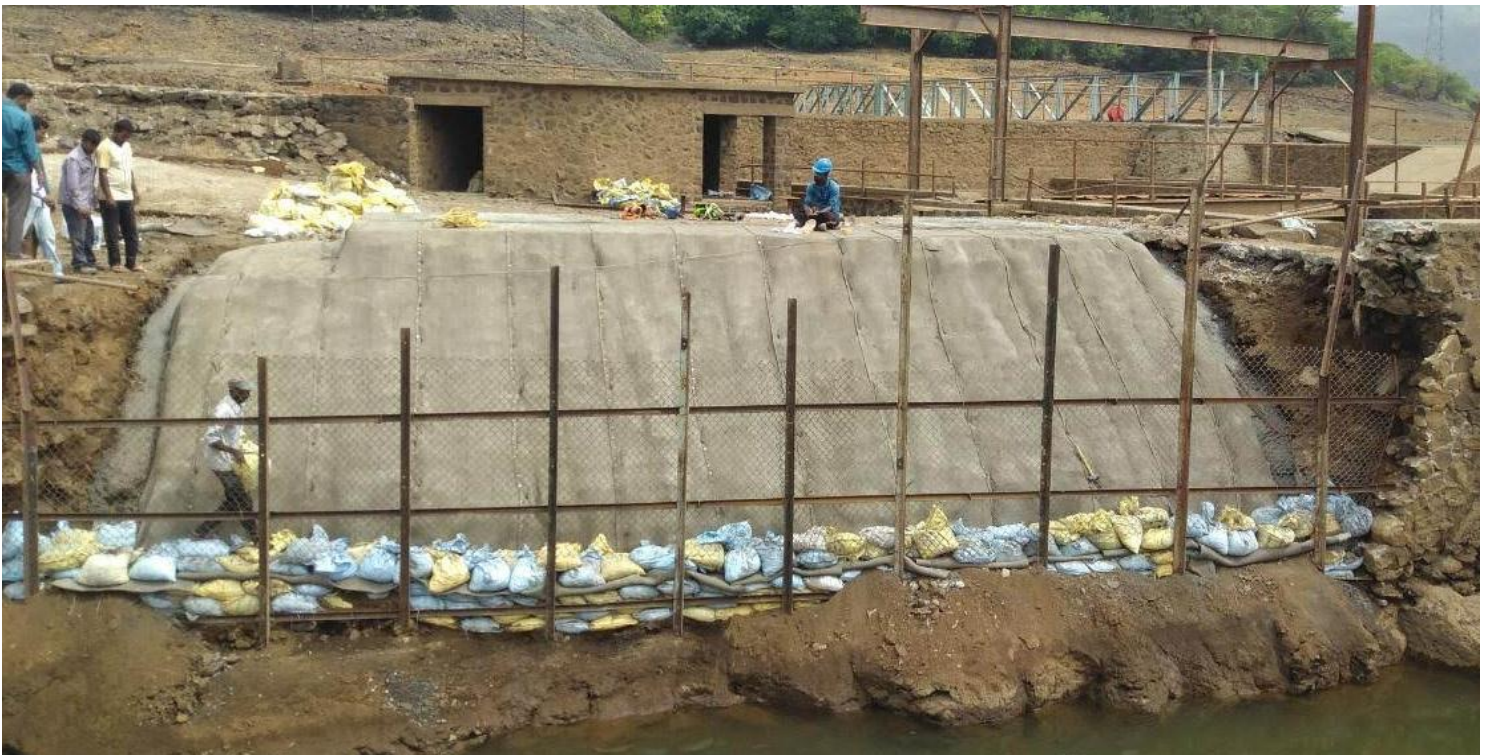
Complete Installation
