## Project Info

Kaunpui, Mizoram

NFR- SSNR Const.

Channel formation to divert leakages from tunnel top

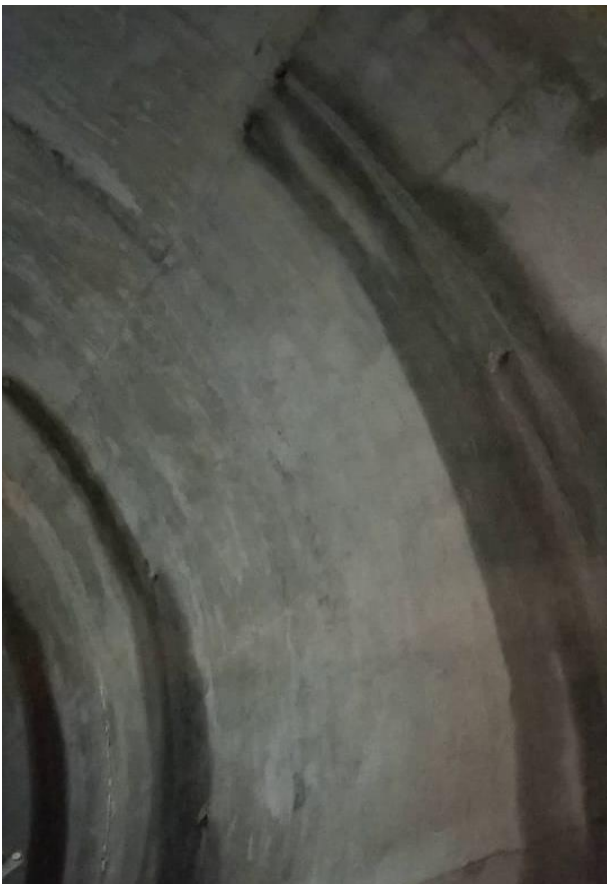
*Leakages from top & side walls*

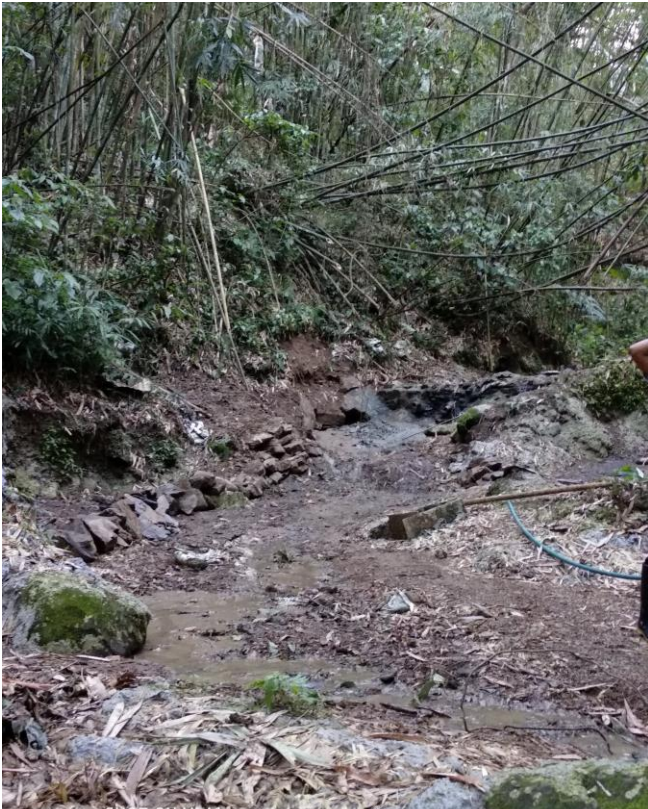
Upper portion of tunnel

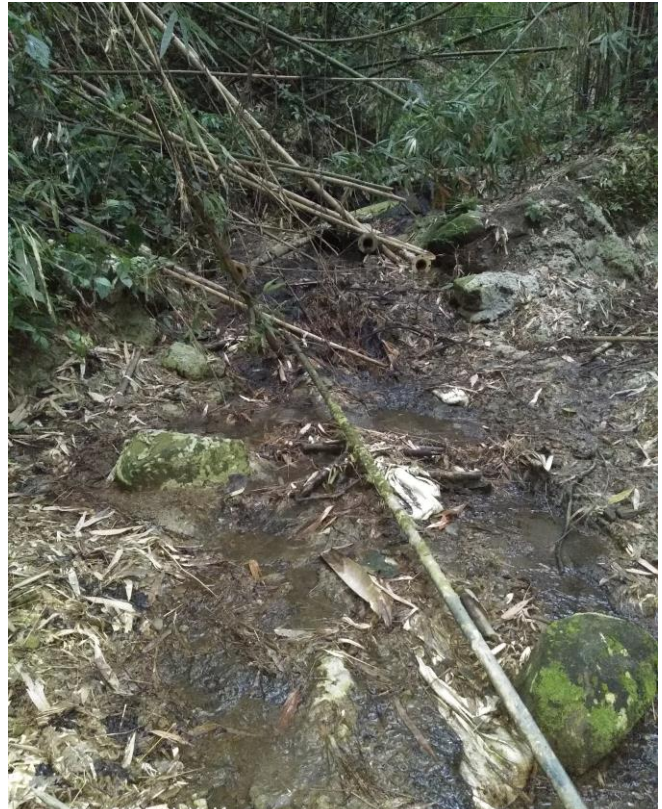
Upper portion of tunnel

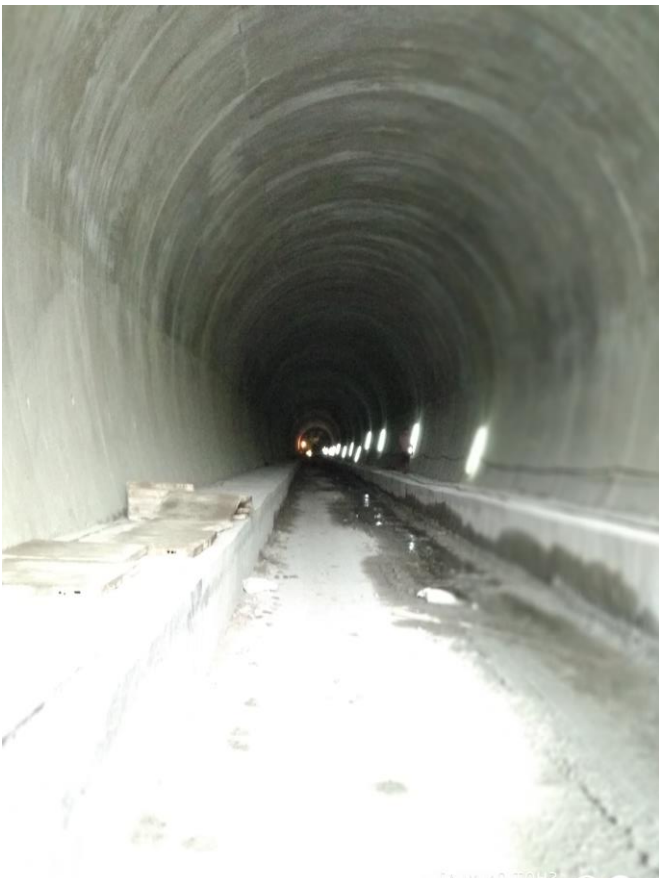
*No leakages inside the tunnel*

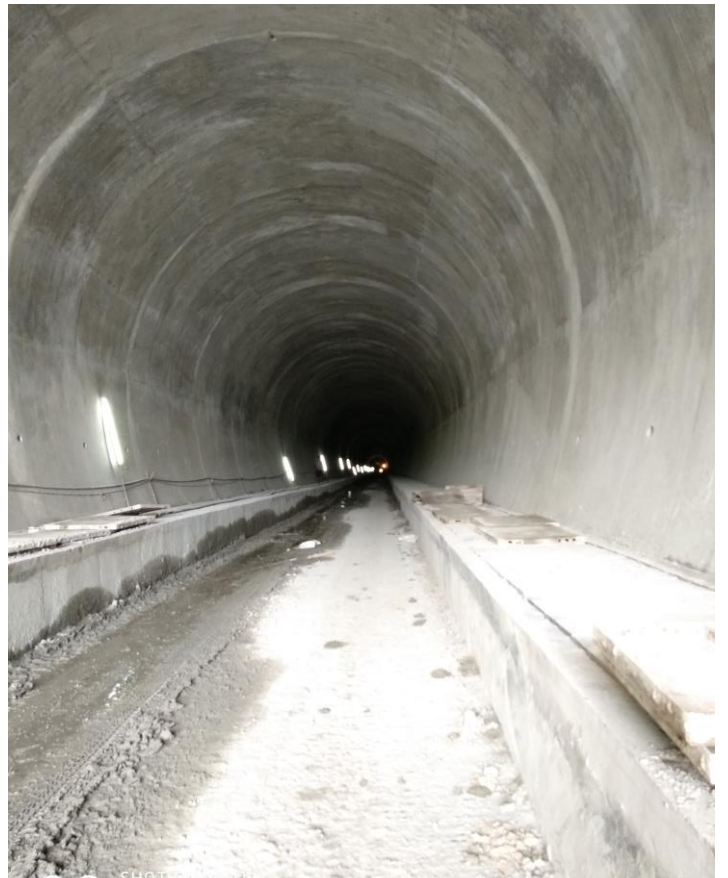
*No leakages inside the tunnel*
