CONCRETE CANVAS

ARRESTING LEAKAGES IN ROAD UNDER BRIDGE

At the Secunderabad Yard line station; there are certain leakages on the joints between two concrete blocks. The subway below it is in use and facing water leakage through the gaps. The client want to use Concrete Canvas Hydro on the main joints and Concrete Canvas on the abutments for protecting leakages.

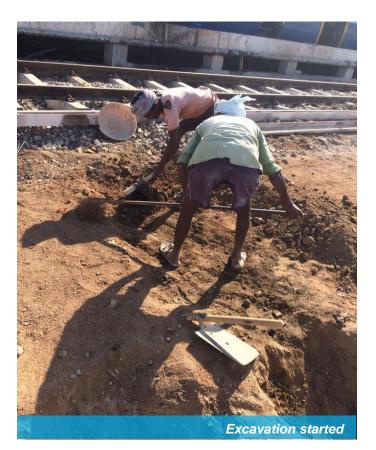
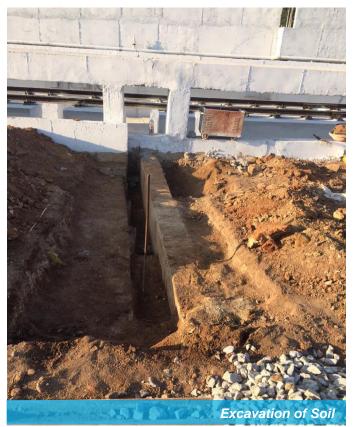
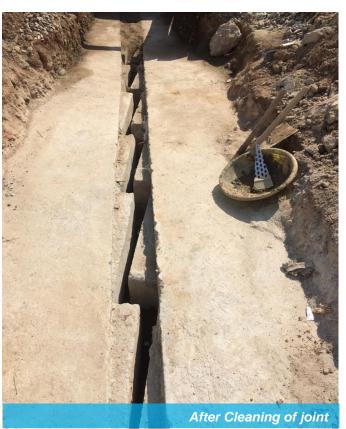
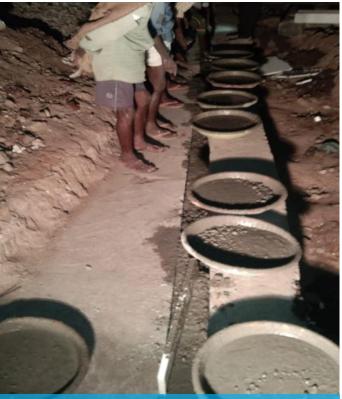
Concrete filling in joints

In January 2019, we started the work on protecting the leakages. We follow our standard installation steps. First of all we did excavation of the ballast and soil above the joints. We made the joints dust free for our installation. In next step we fill cement concrete in the gaps as the gaps were so large. After proper compaction and settling of concrete we started to lay the concrete canvas and concrete canvas hydro over it. Fixed it with silicon sealant and hilti nails and assure there will be no leakages and gaps between CC and the surface. We did the work in a week with 6-8 labours a days including site preparation time and backfilling of railway subgrade.

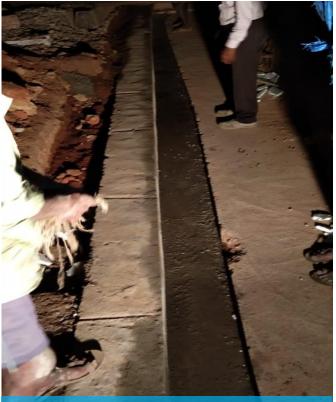
Filling of joints with concrete

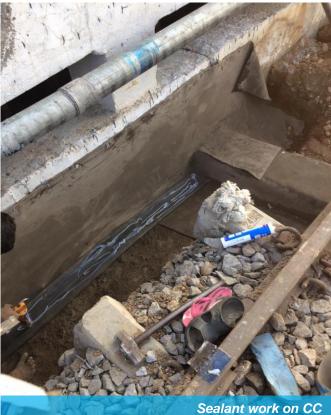
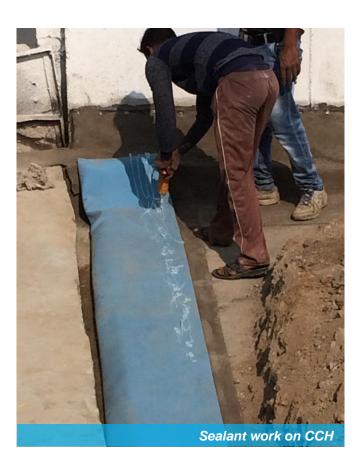
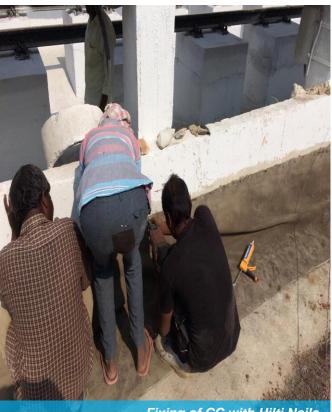
Fixing of CC with Hilti Nails

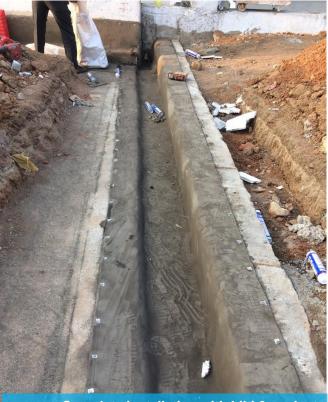
Complete installation with hilti & sealant

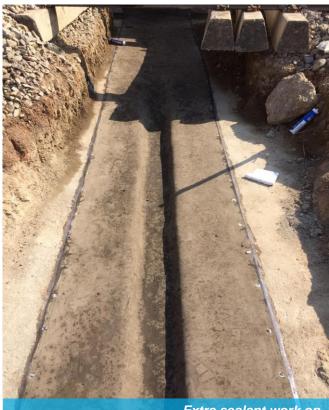
Extra sealant work on
