CC5

Wrapped Pattern

NR Guest House

Northern Railway

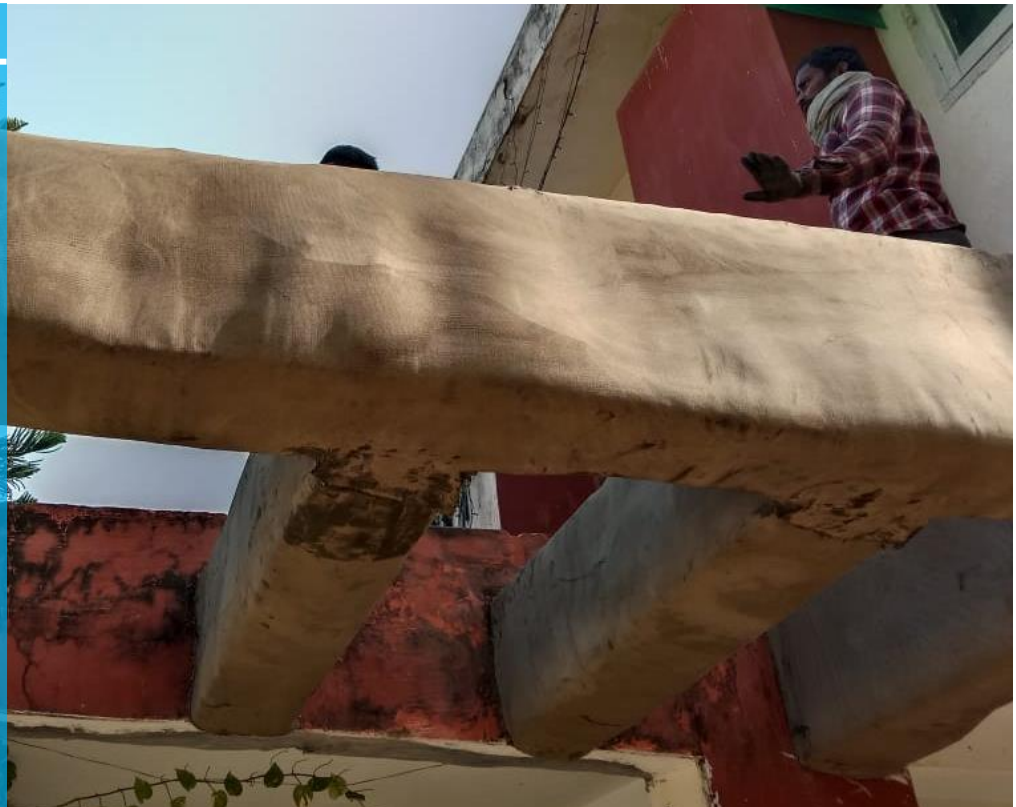
Completed Installation

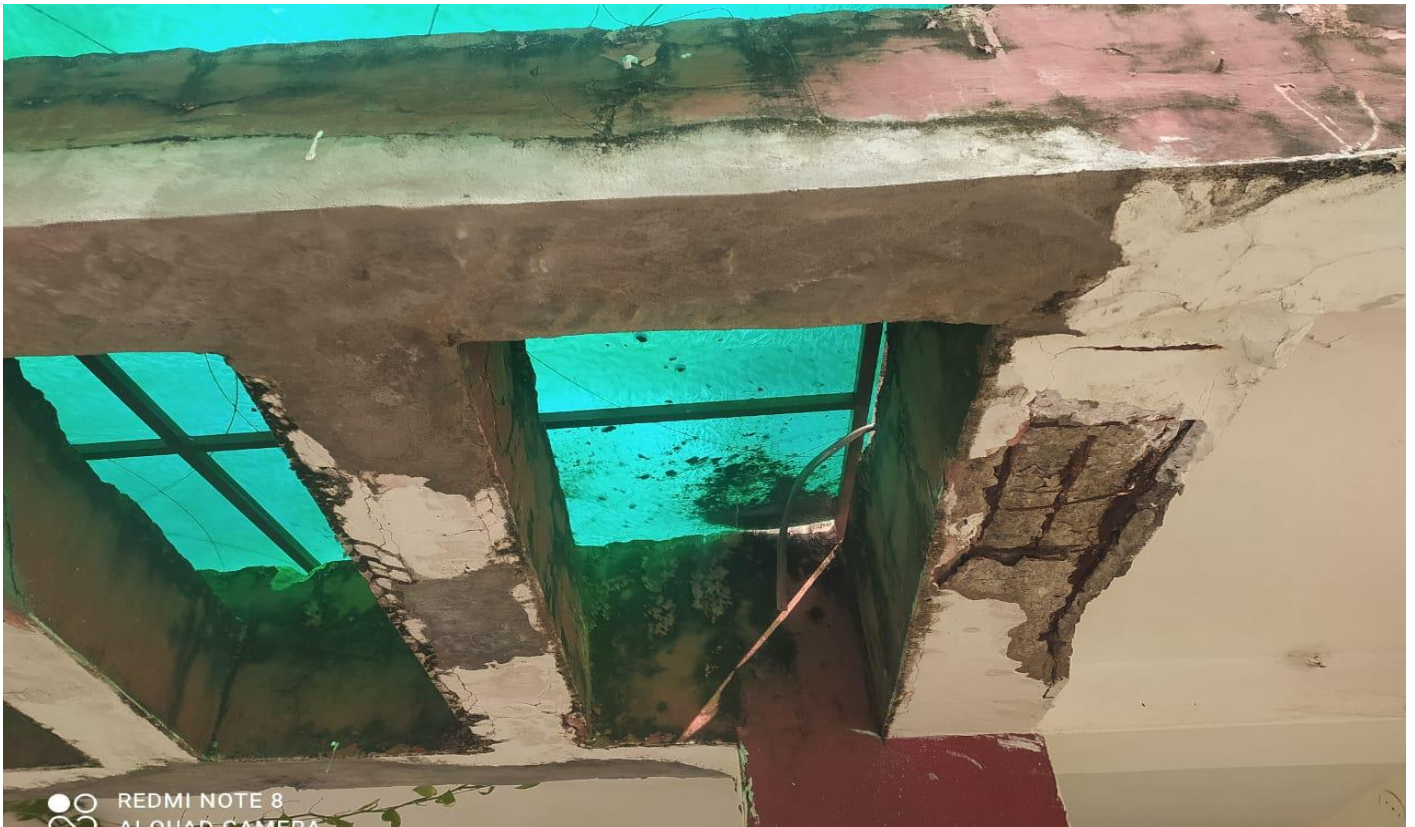
The beams constructed as a decorative porch area are damaged heavily and eroded due to weathering actions & rains. After concrete portion collapsed, the reinforcement steel bars are begun to corrode due to exposing to environment & moisture. This can lead to failure of the beam structure and also aesthetically was not looking good.

Initial eroded porch beams

We were approached by Dy. CE Construction 1, Ambala for this small amount of work possibility by Concrete Canvas. As Concrete canvas has extreme weathering durability against heat, temperature, rains, snow, wind, abrasive forces, UV rays & other natural loads/forces, etc. so basic minimal thickness 5mm was selected for the work.

We marked a basic layout drawing with provided dimensions and CC5 can be wrapped around the beams with sufficient overlapping & fixing edges so CC5 15sqm material was sent & installed in one working day with 4 labours & one supervisor. Fixing at top done by Hilti nails & Bidding strips were provided for covering overlapped area. The installation was fast & effective. The authorities were pleased with the material installation & hope to work with the material for other major railway works.

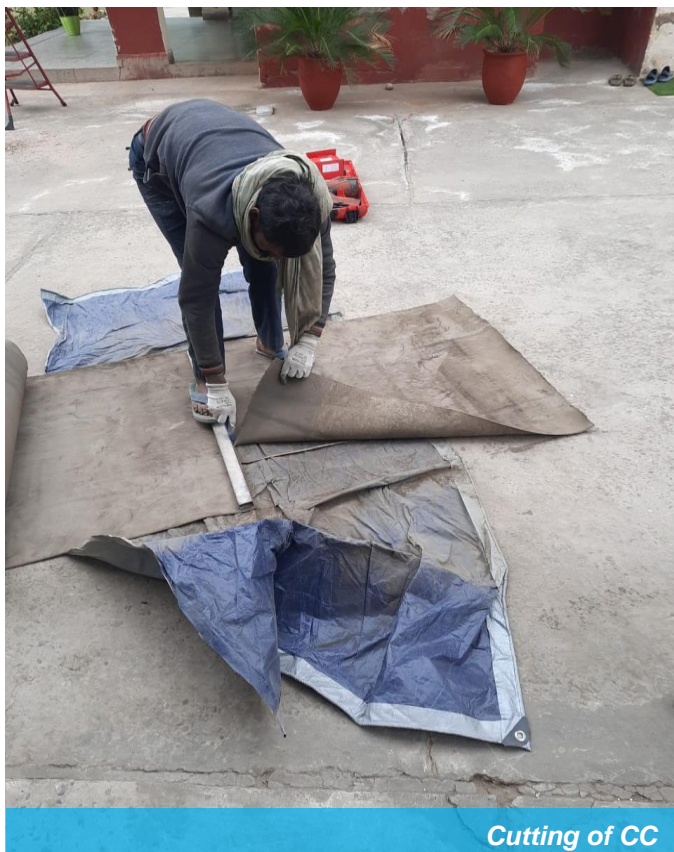
Cutting of CC

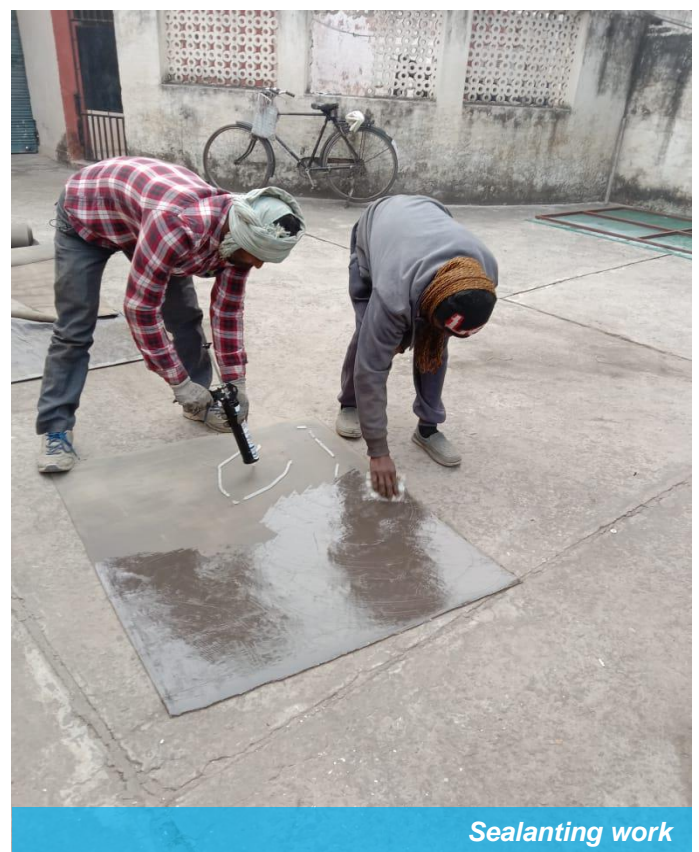
Sealanting work

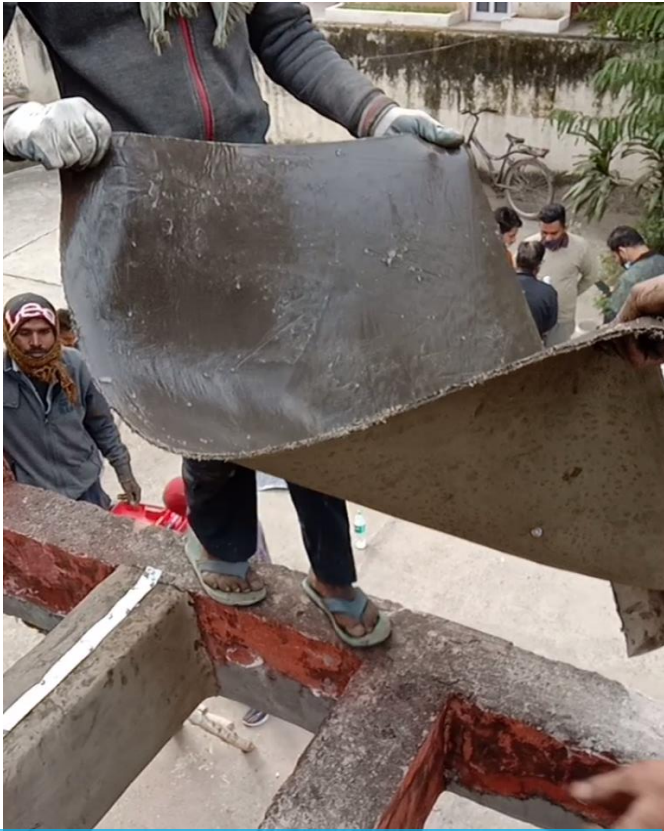
Placement of CC over beam

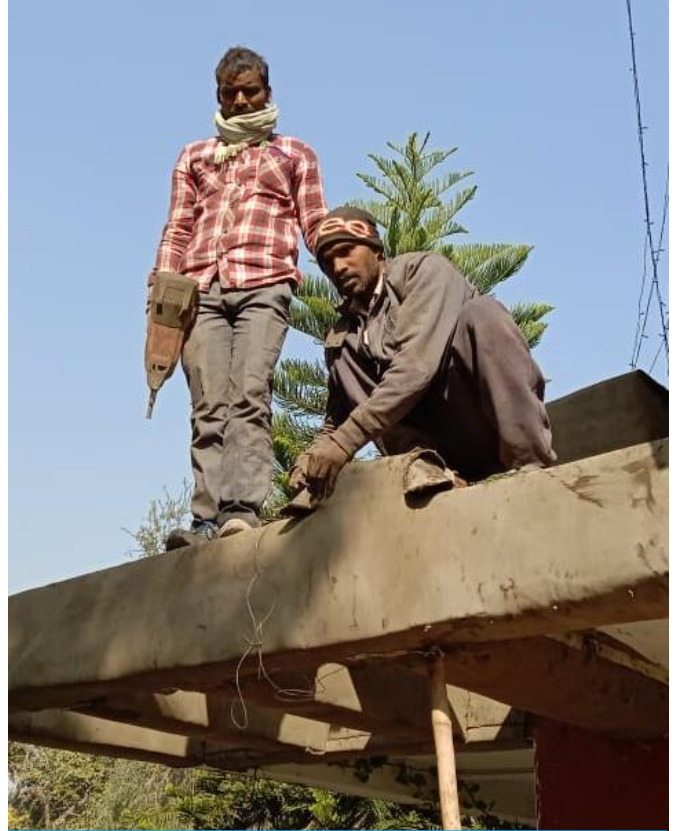
Hilti Nailing work

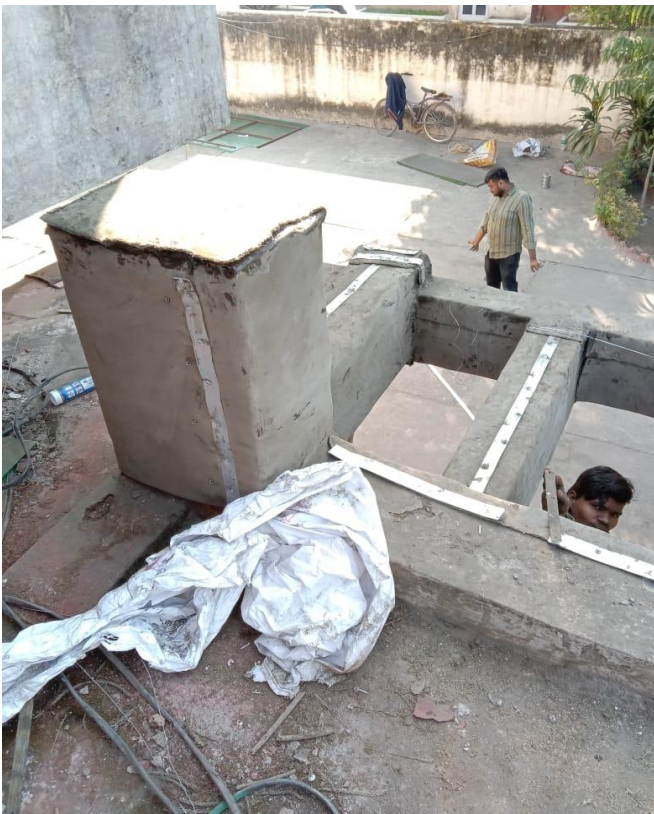
Top Fixing

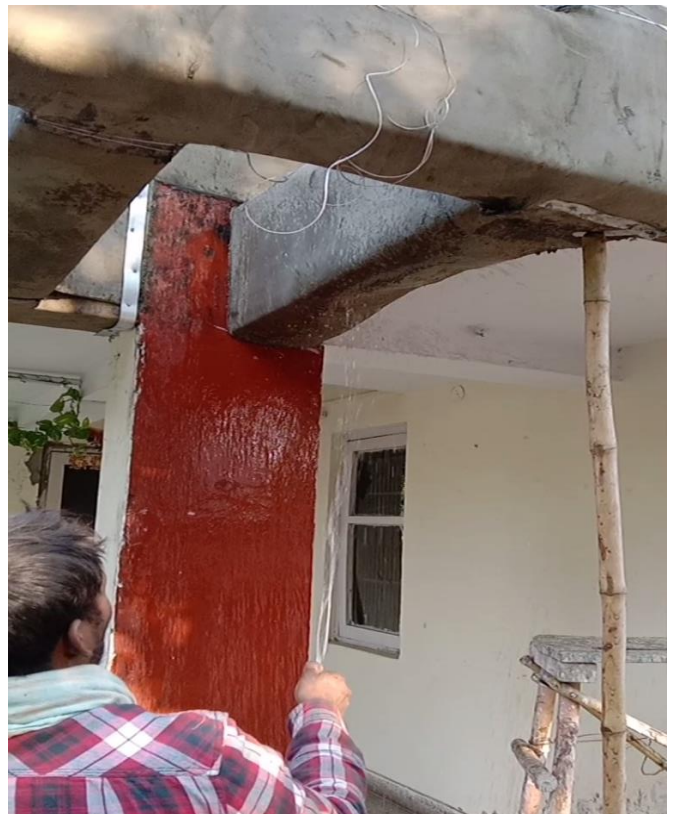
Hydration of CC

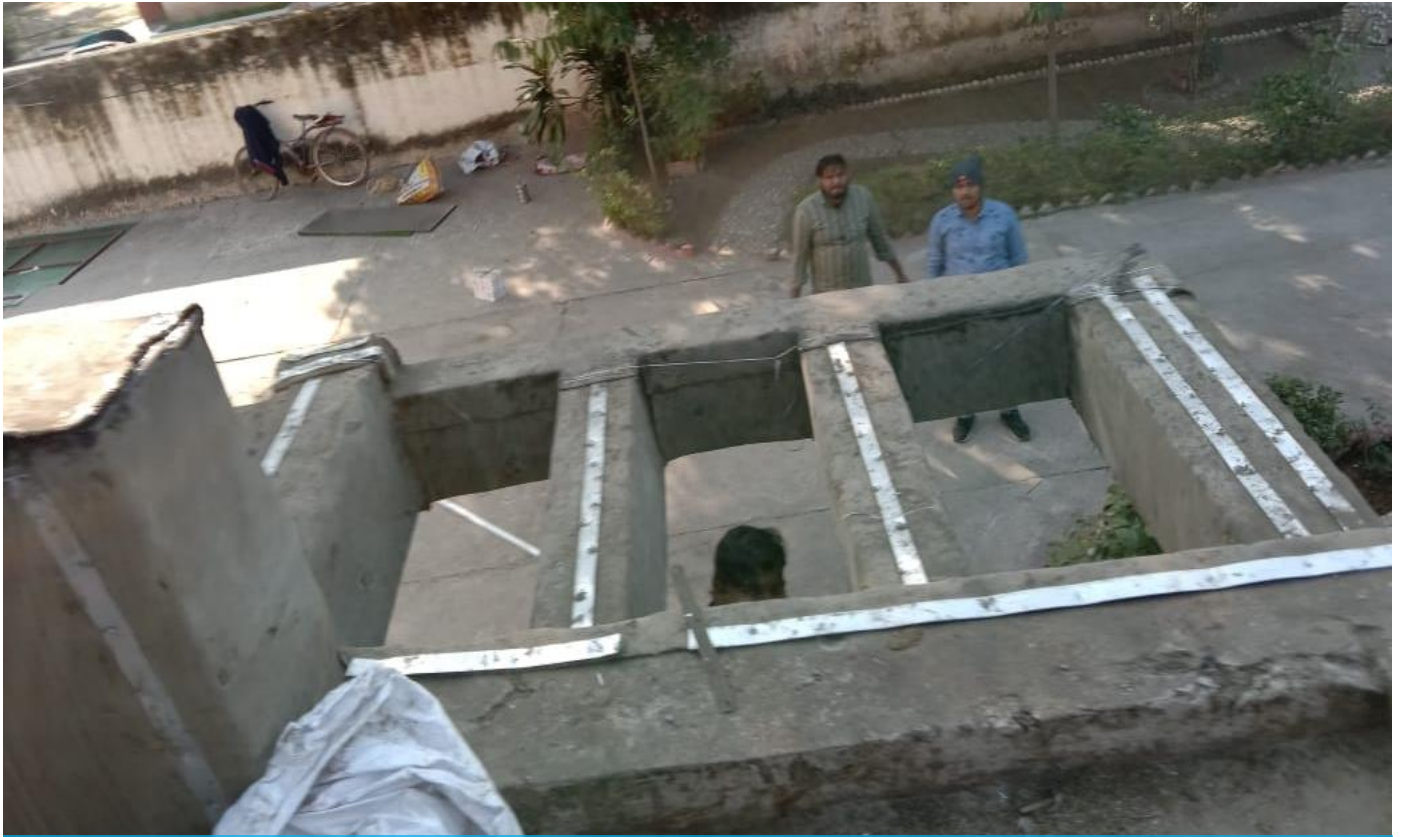
Top View of Completed Installation

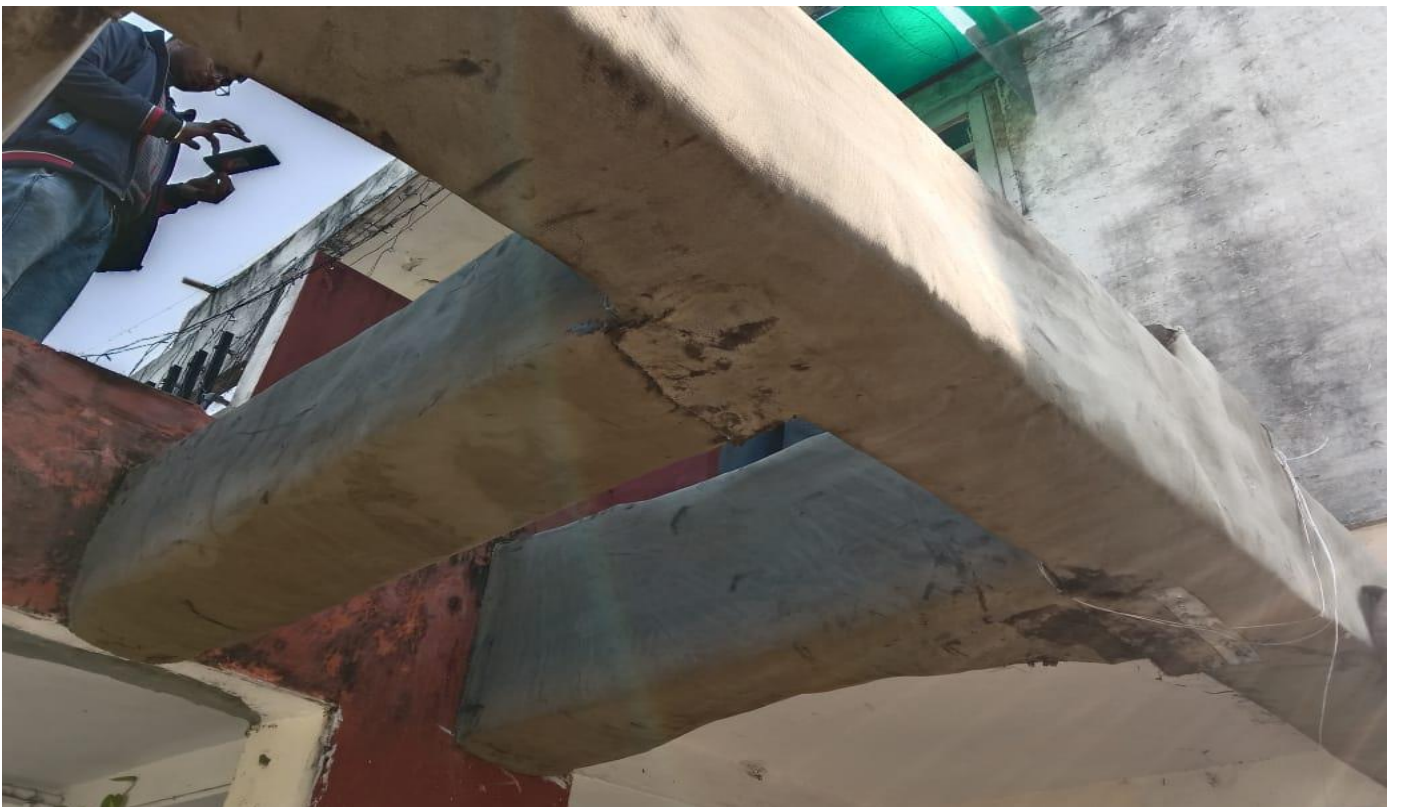
Bottom View of Completed Installation
