Project Info	
 	July 2017
 	CC8™
 	3575sqm
 	Longitudinal Layer
 	Azimganj
 	Eastern Railway

The work was allotted by Dy. Chief Engineer, Cons-IV/Howrah to control the erosion problem in railway embankment on newly laid trackway near Ajimganj route.

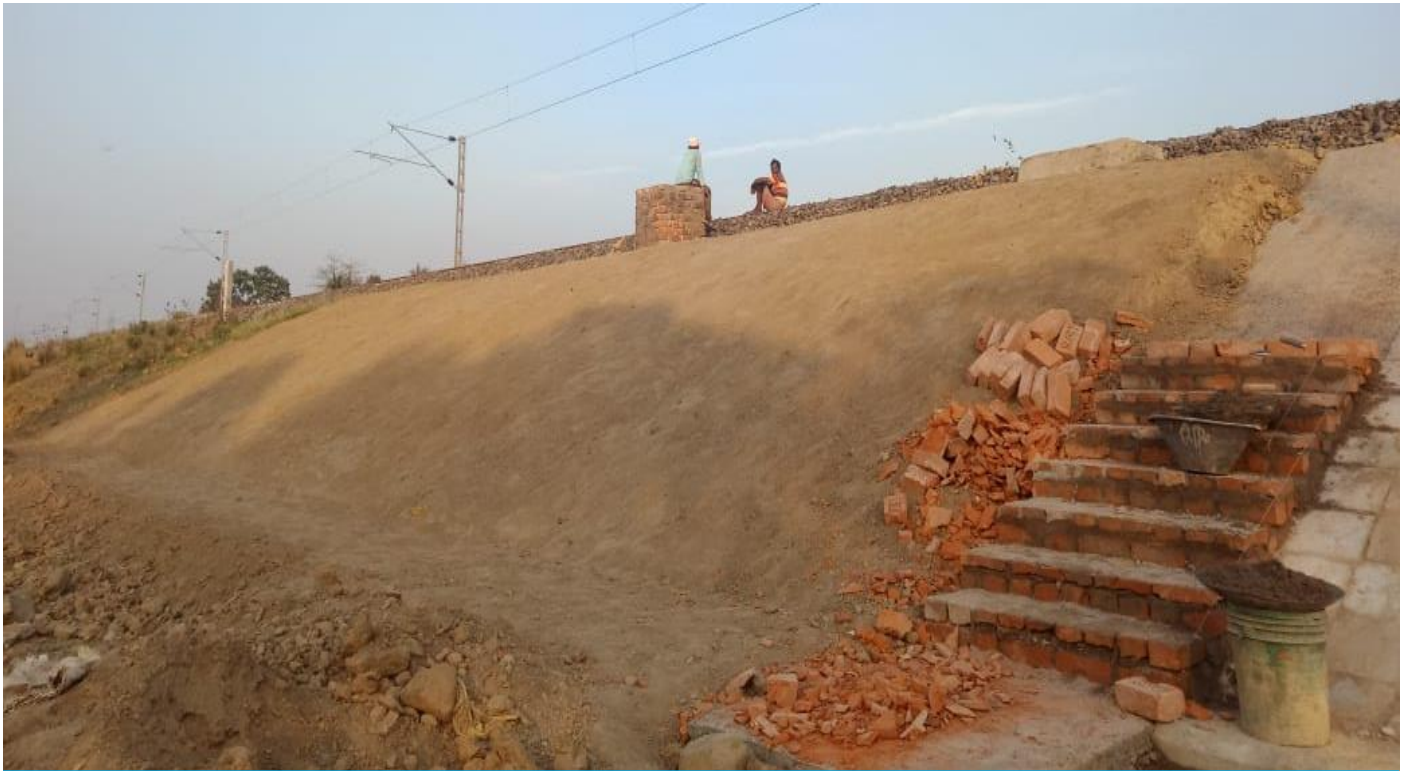
Laying of CC on levelled profile

In July 2017, the work has been started to protect the slope from erosion of soil. First of all, we clear the surface from shrubs and fill the pit holes with soil and tried to even the slope and dressing was done. After that measured cut pieces laid on slope one by one with overlap of 100 mm between two pieces of CC then fixed it with the help of pegs having 1.5-2.5 meters length (On each 1m. interval) & 1.5" fully threaded round headed screws having washers. Two lines of screw are maintained on the overlap for better fixing result (each at 200mm distance in straight and 100mm in zigzag way). Insert ½ mt. Concrete Canvas on Both sides drain with using Pegs for Fixed and done concreting on Drain portion. Then cure it with water for one with 2-3 hours intervals.

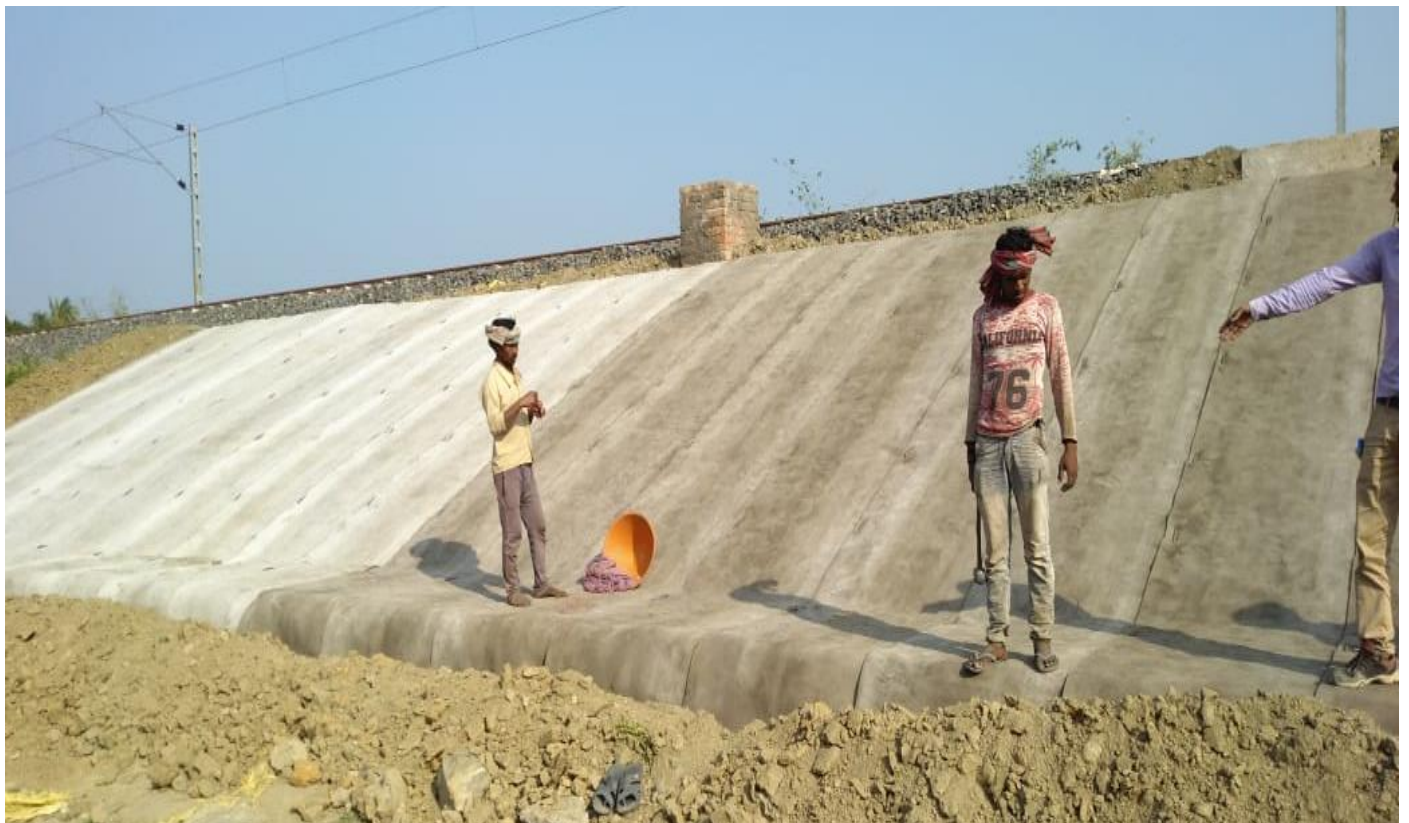
Screwing on overlaps

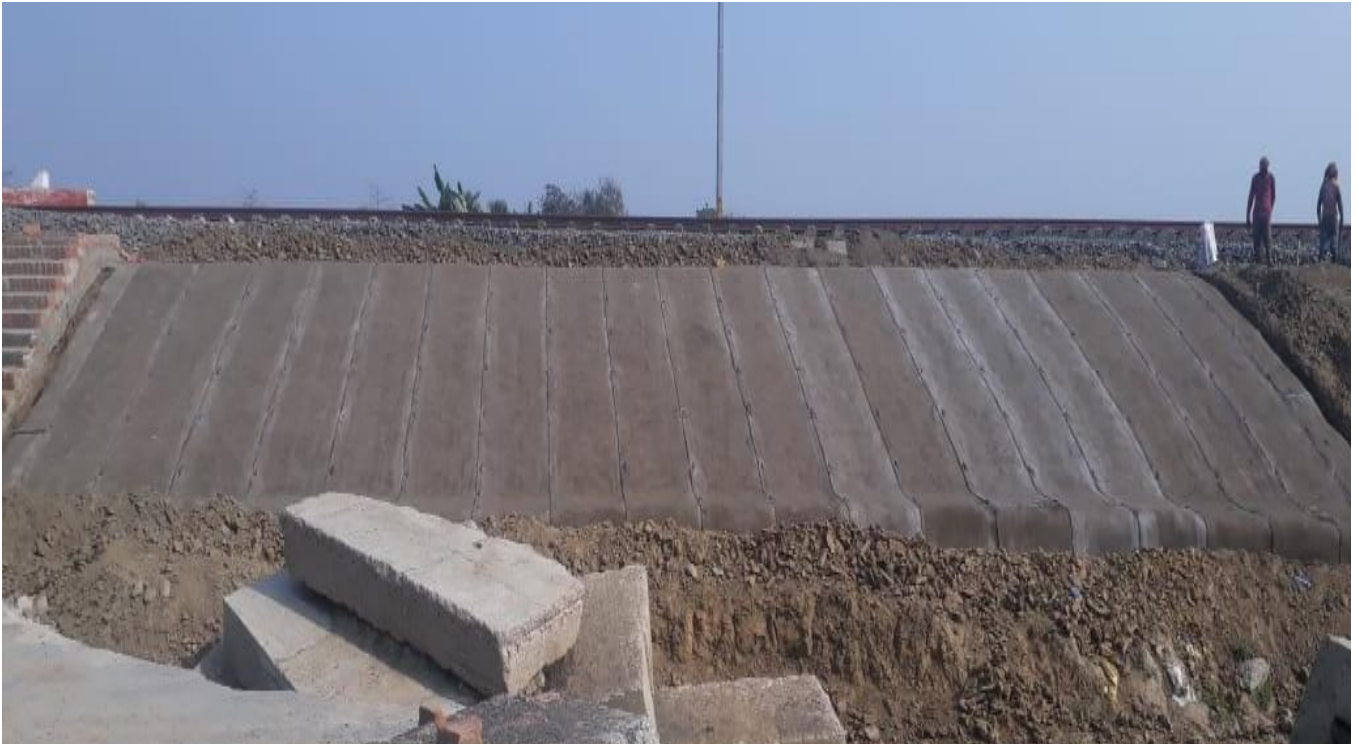
Location 2 Installation completed

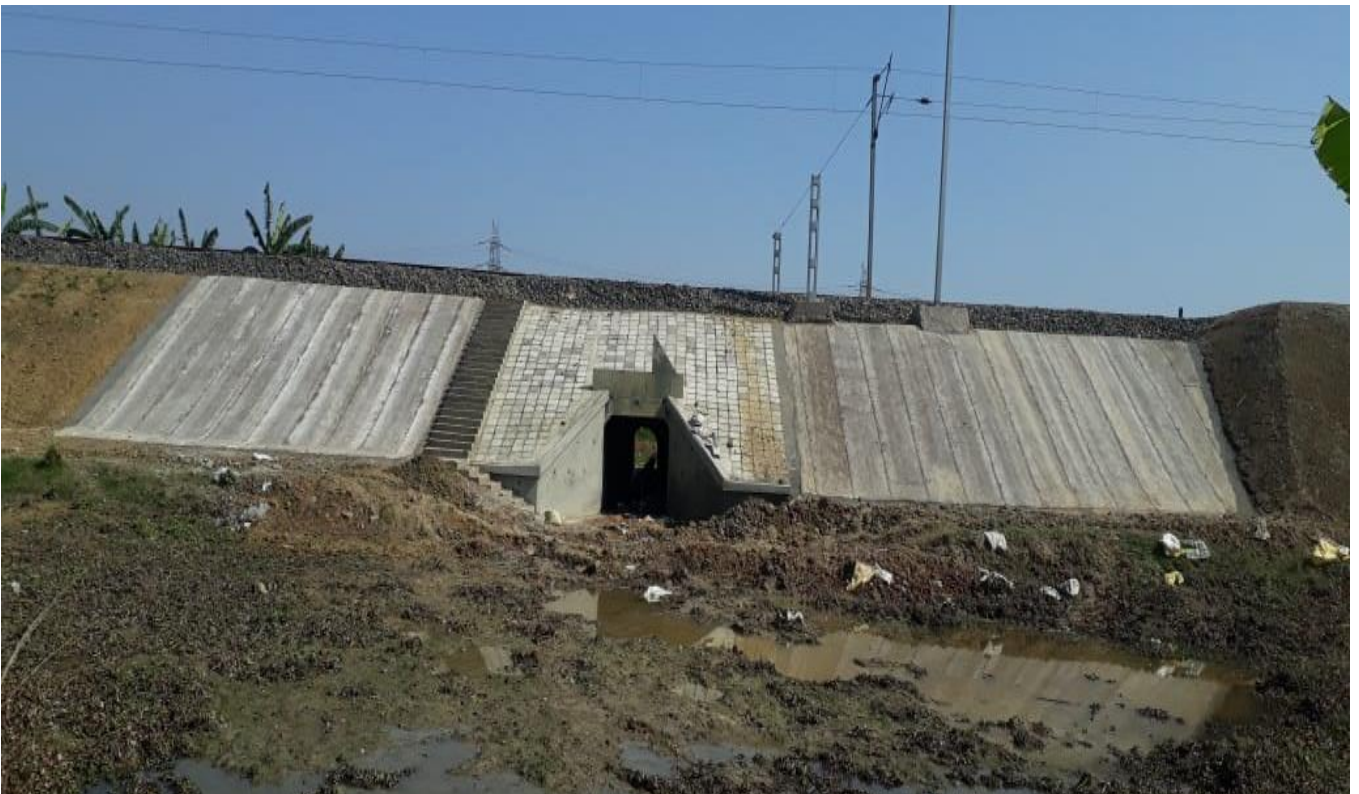
Location 3 Installation completed
