SLOPE EROSION PROTECTION

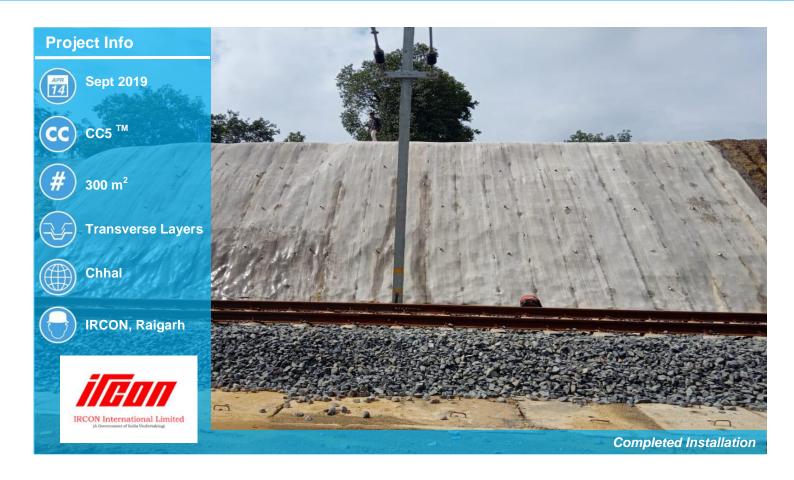
The laying of new track lines in cutting section near the Chhal, Kataipalli C village is in progress back in August 2019, when we first visited site. After visiting the site it was observe that due to weathering action & heavy rainfall in area, the soil on a site becomes loose and there is a problem of erosion. Eroded soil continuously fall on the water drain which is constructed at end of the embankment of newly laid tracks. Due to heavy subsurface flow, rain-cuts & problem of landslide was observed in most of the cutting slopes.

We started discussion with IRCON officers in same issue and need of Concrete Canvas on the area. The authorities decided to go with trail work of 300sqm immediately without wasting time. From Sept 23 to Sept 30, 2019 we did fastest possible installation with minimum team of 12-15 labours per day. The work was interrupted repeatedly due to rainy season. Most of preparation days were wasted due to same but still our skilled supervision made the project to be completed in merely one week.
