Project Info

CC5™

Devarayi-Shivathan

RVNL Hubli

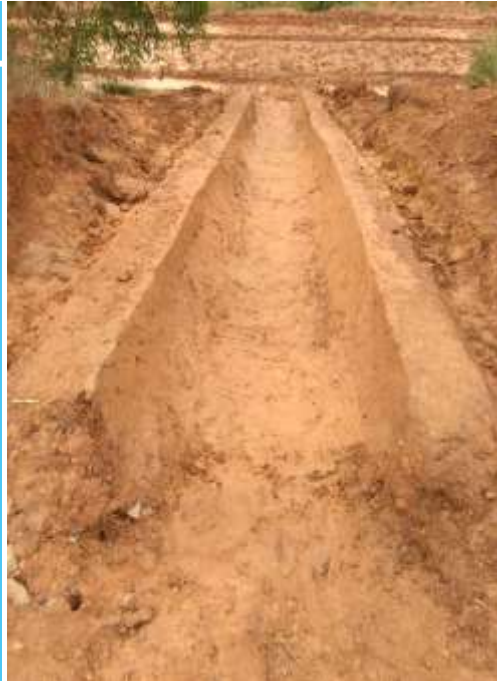
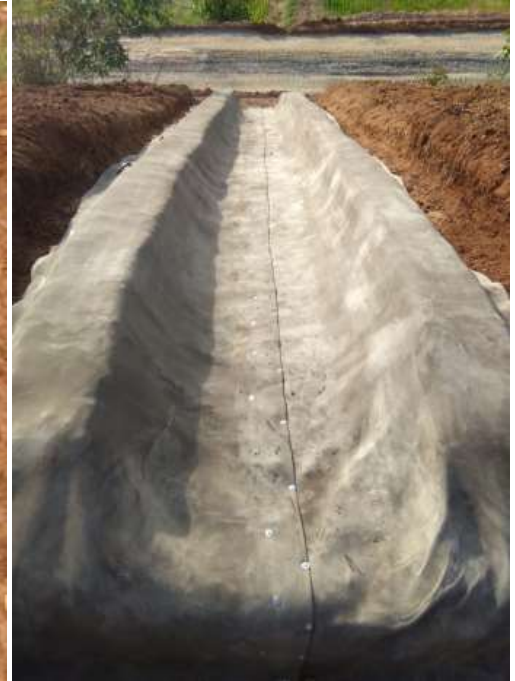
Installation Completion Photo

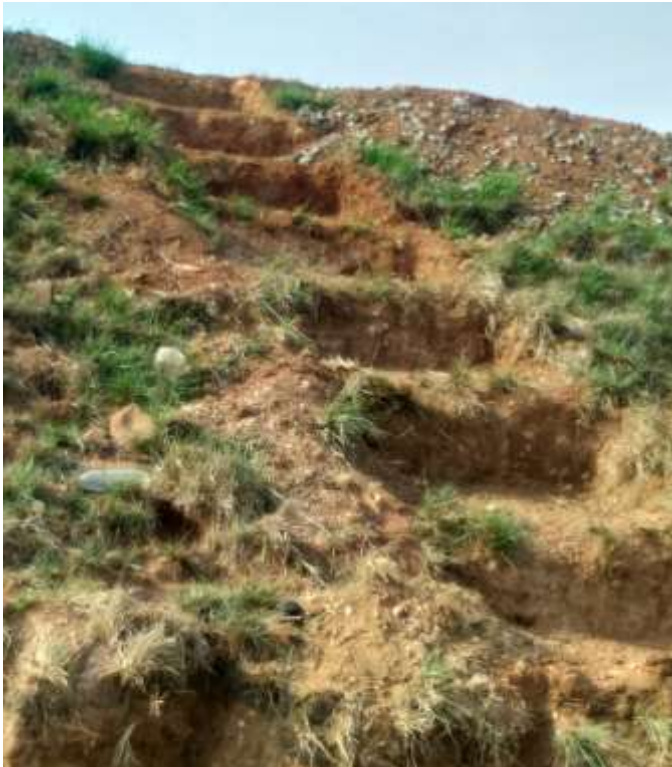
There is an ongoing new railway construction & track laying work going on between Devarayi to Shivathan station under RVNL Hubli. After laying of railway track there are some old existing outfall works done on soil & some are done by concreting which are now vanished & totally damaged due to multiple seasonal rains & wind.

Before Photos During Site Visit

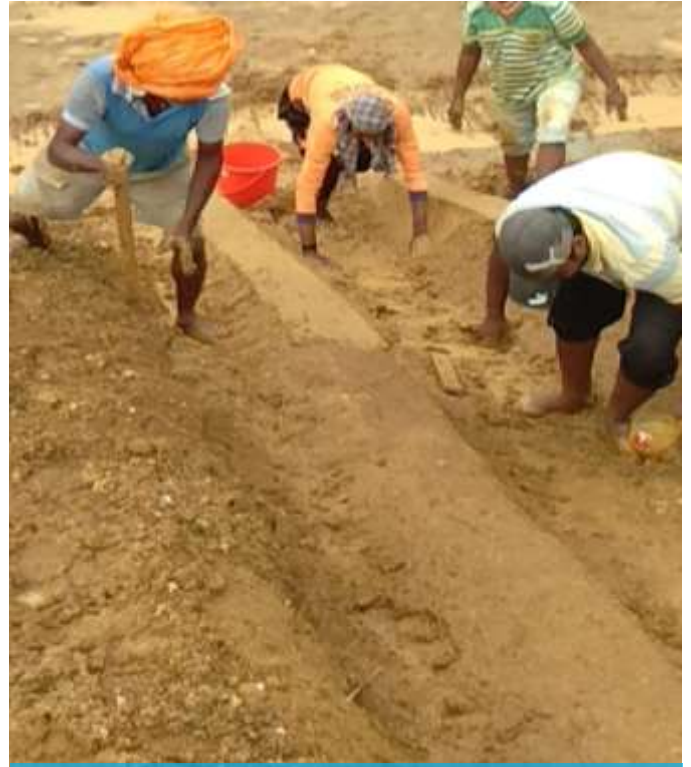
Outfall Profile Preparation

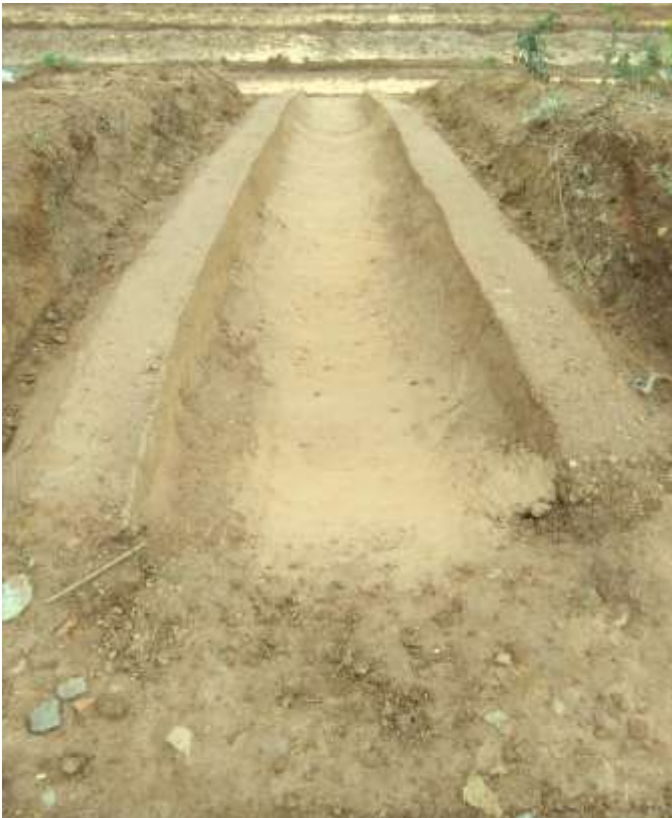
Prepared Surface

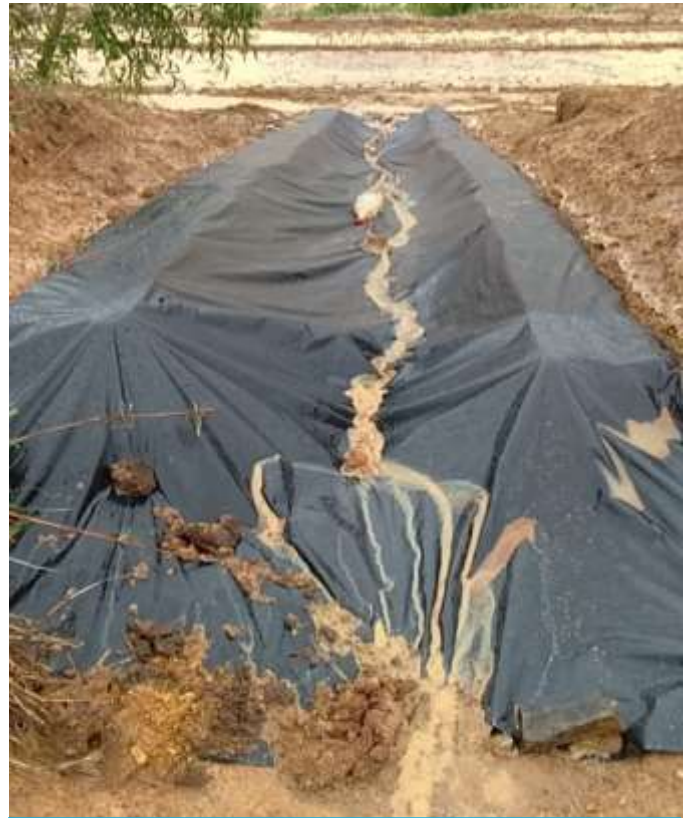
Protection With Tirpal From Rain

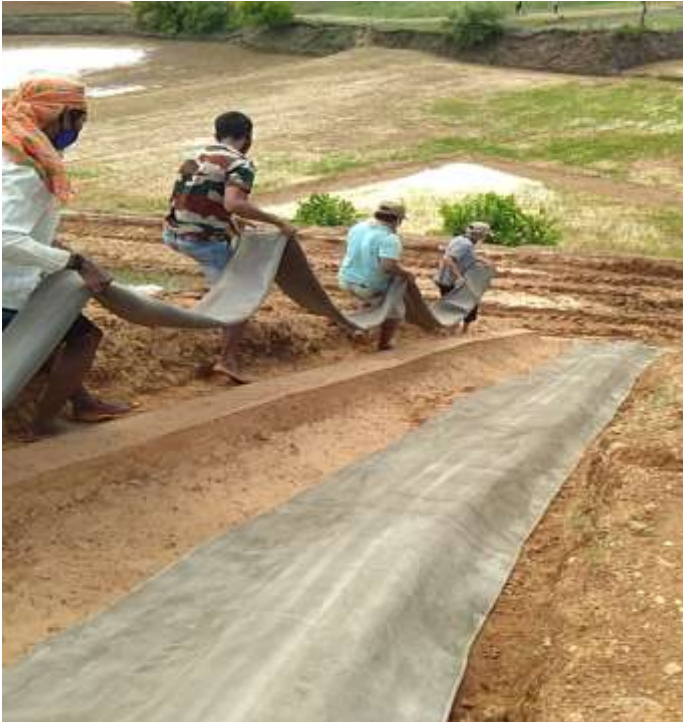
CC Laying

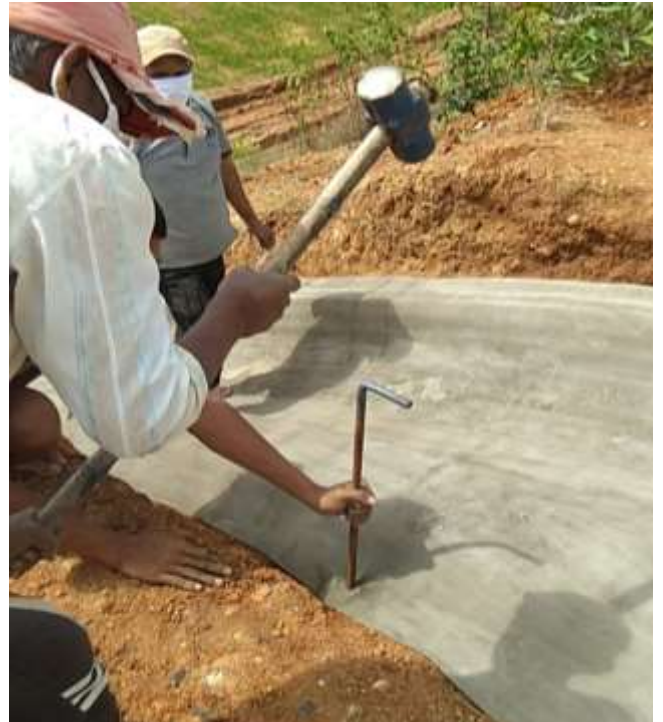
Peg Fixing

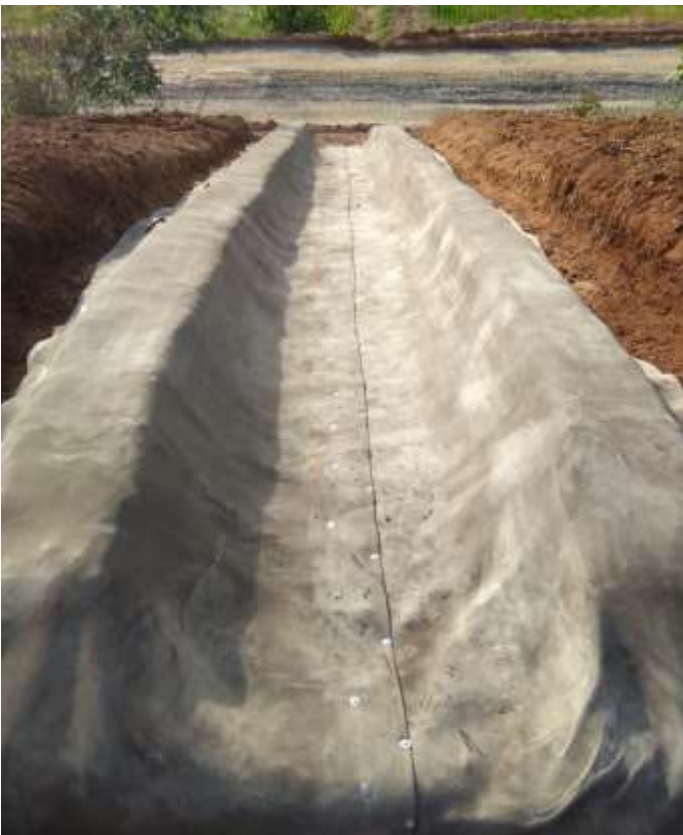
Fixing & Screwing Done

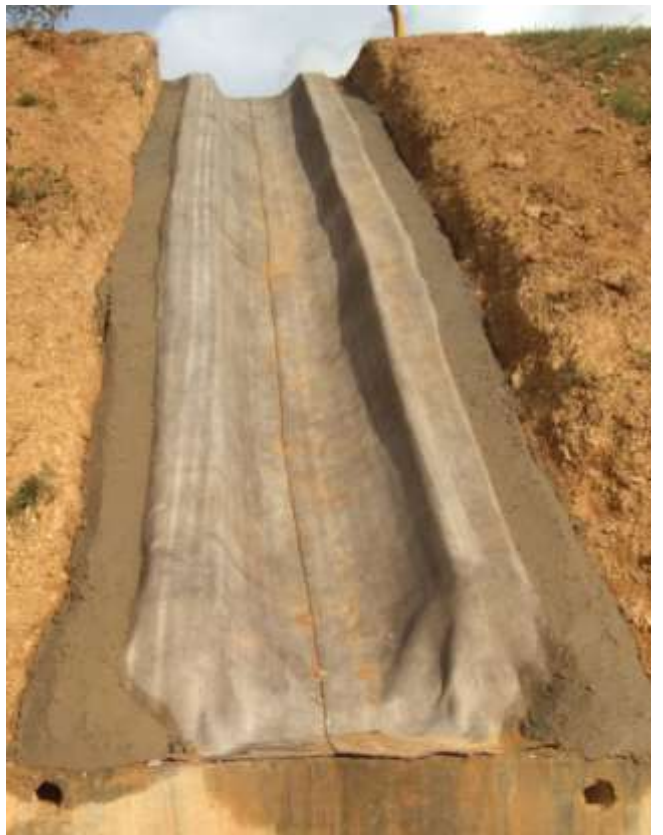
Completed Outfall
