CC CC8™

# 1740 sqm

Sangaldan, J & K

Velecha Construction & Konkan Railway

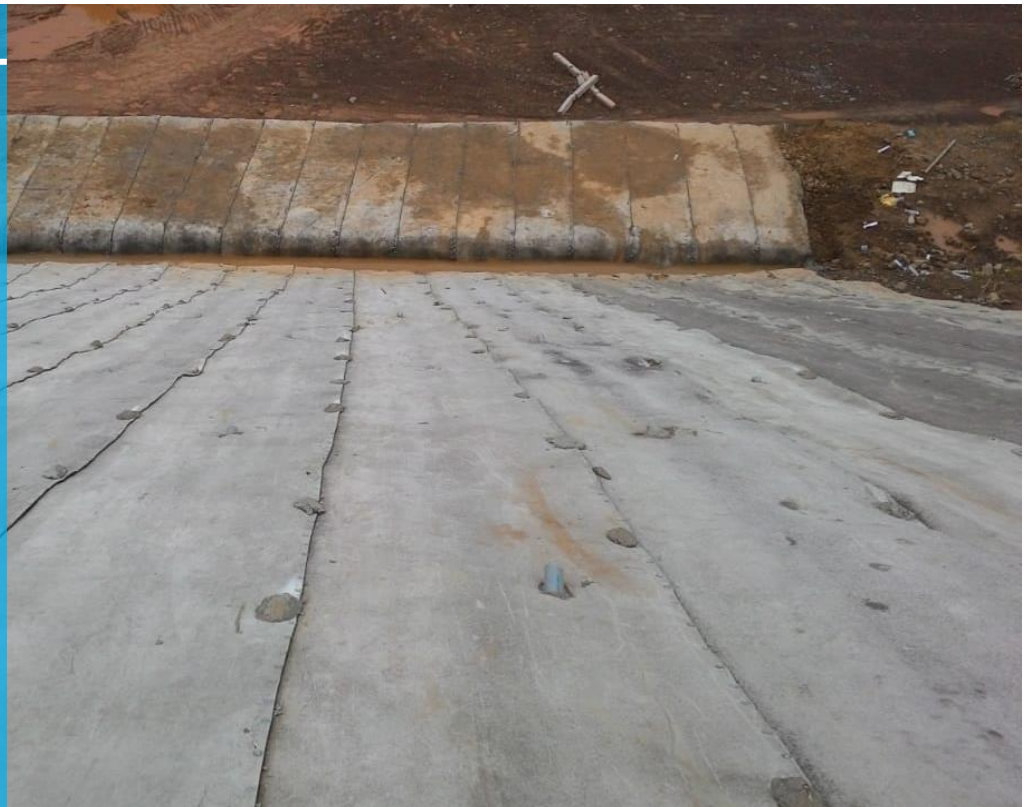
After one year of completion of work

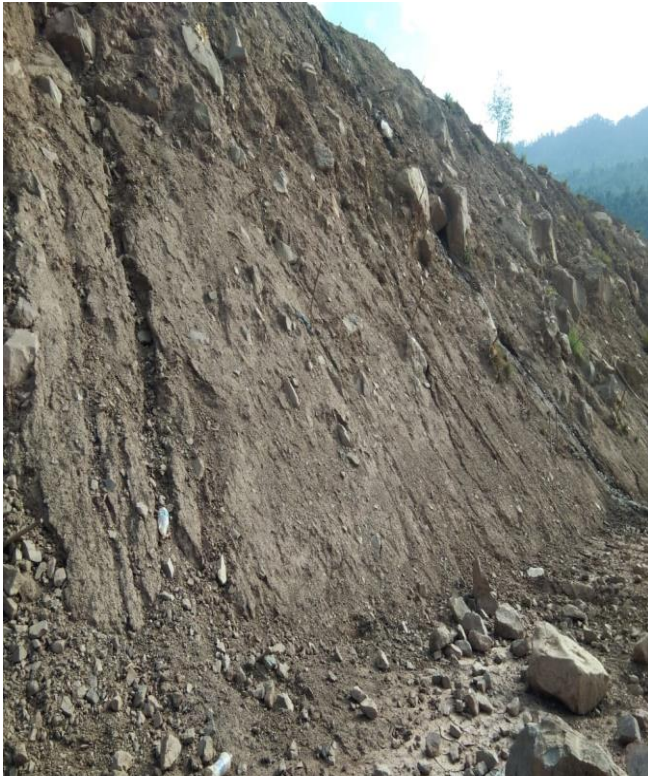
After visiting the site it has been observed that the work of railway track is under construction in embankment or filling and the soil is very loose. Road under the bridge is getting jam due to heavy rain, the soil of the slope is sliding with water towards the lower side & because of that the base of newly constructed railway line getting weaker. It is very dangerous for railway track; hence it is to be rectified.

*Before Site Preparation*

In July 2018 the work has been started to protect the slope from erosion of soil. First of all, we clear the surface from shrubs and fill the pit holes with soil and tried to even the slope and dressing was done. After that measured cut pieces laid on slope one by one with overlap of 100 mm between two pieces of CC then fixed it with the help of pegs having 1.5-2.5 meters length (On each 1m. interval) & 1.5" fully threaded round headed screws having washers. Two lines of screw are maintained on the overlap for better fixing result (each at 200mm distance in straight and 100mm in zigzag way). Weeping holes of PVC Pipes having 1.5 inch diameter also use to remove percolated water in soil so that it will decreases water pressure in inner portion. Insert 1/2. Concrete Canvas on both side drains with using pegs for fixing and do concreting on drain portion. Then cure it with water for one day having 2-3 hours intervals. The Project has completed one year of successful installation.

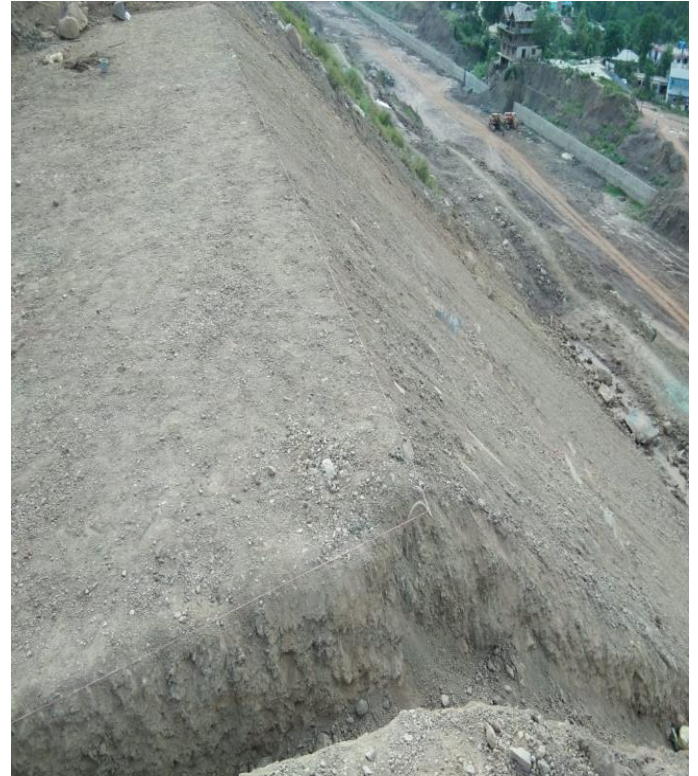
*After Site Preparation*

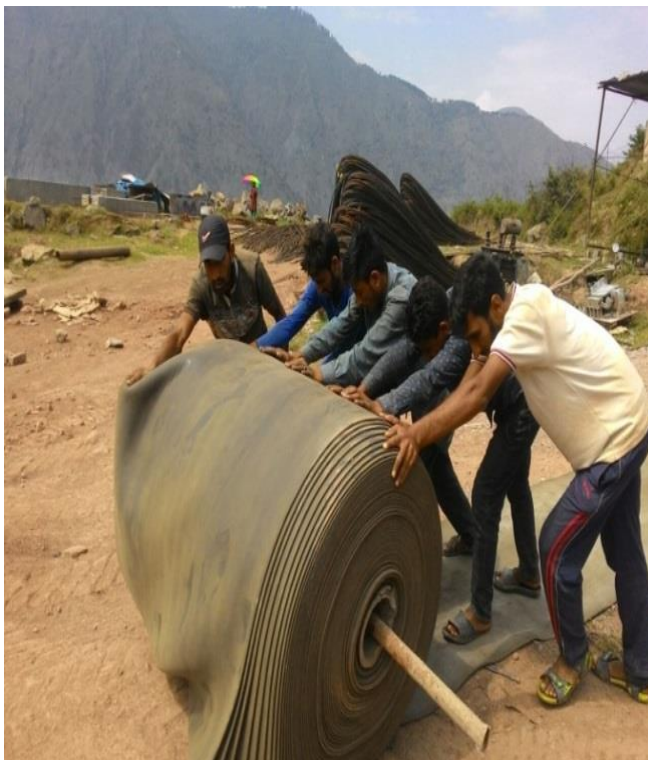
*Unrolling Bulk Rolls of CC8*

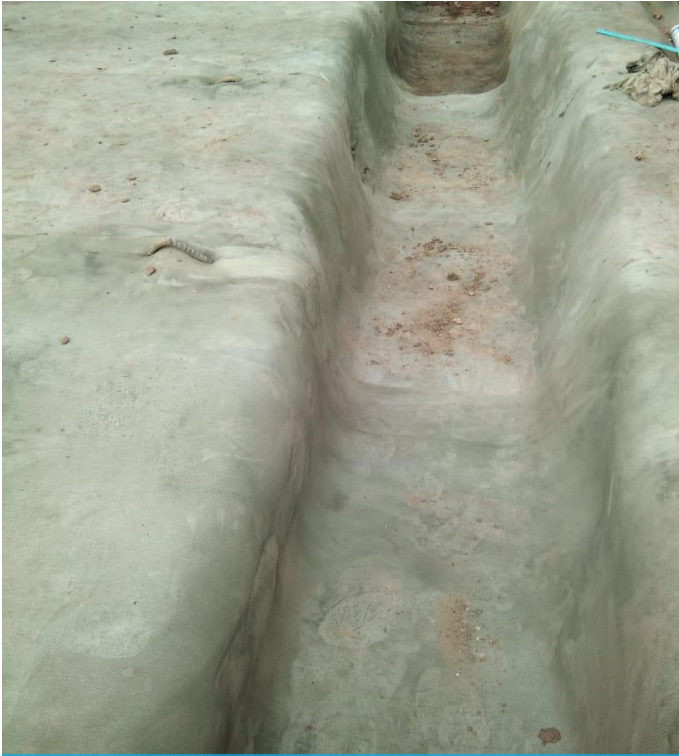
Catch Water Drain on Berm

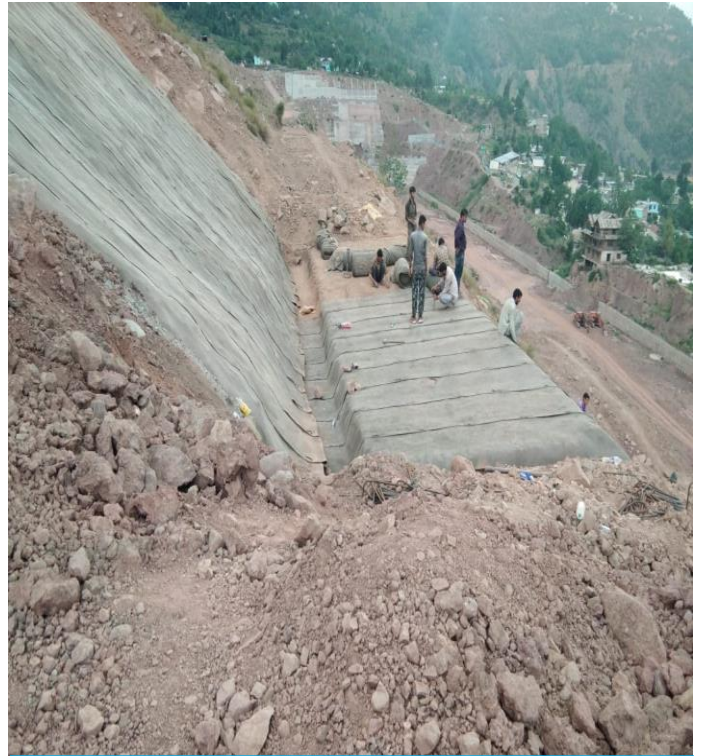
Middle Berm View

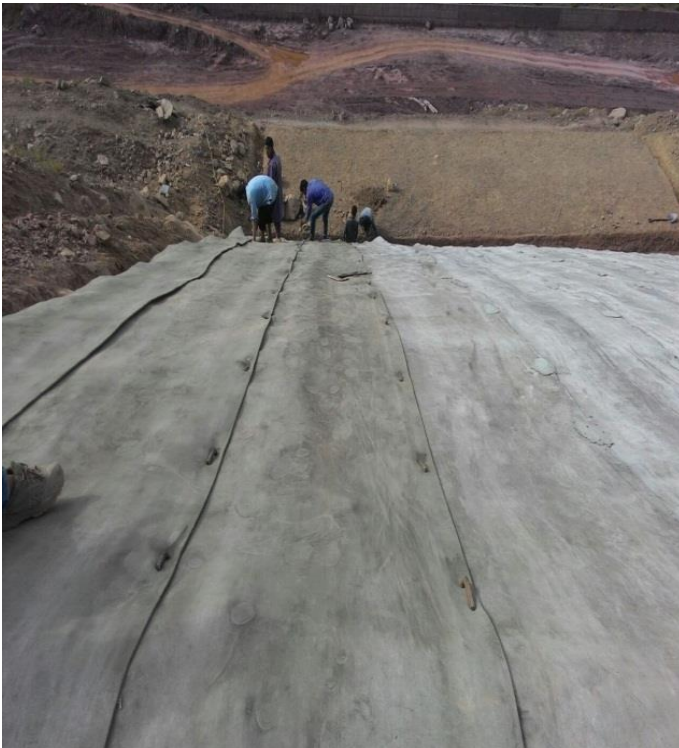
Laying of CC8

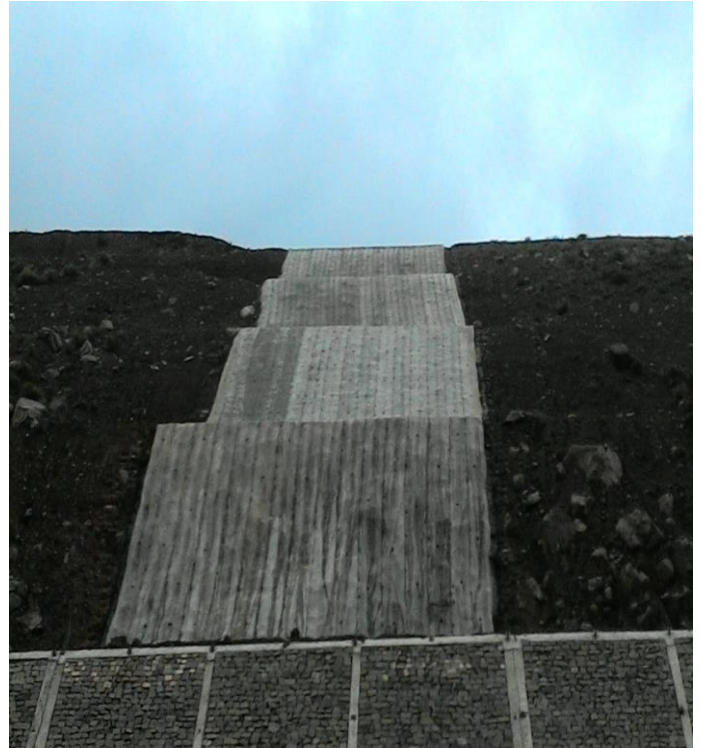
Completed Installation
