**Project Info**

-   **July 2018**
-   **CC8™**
-   **1740 sqm**
-   **Longitudinal Layers**
-   **Sangaldan, J & K**
-   **Velecha Construction & Konkan Railway**

*After one year of completion of work*

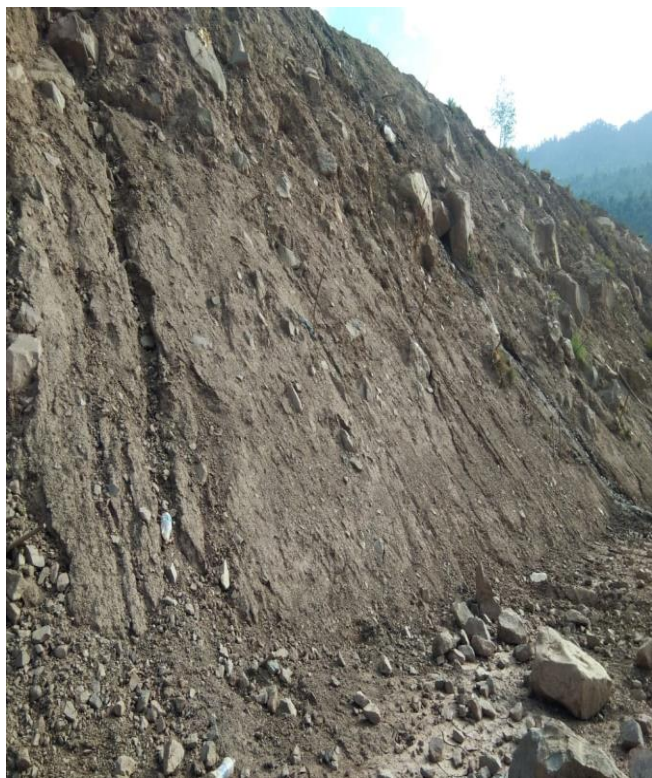
After visiting the site it has been observed that the work of railway track is under construction in embankment or filling and the soil is very loose. Road under the bridge is getting jam due to heavy rain, the soil of the slope is sliding with water towards the lower side & because of that the base of newly constructed railway line getting weaker. It is very dangerous for railway track; hence it is to be rectified.

*Before Site Preparation*

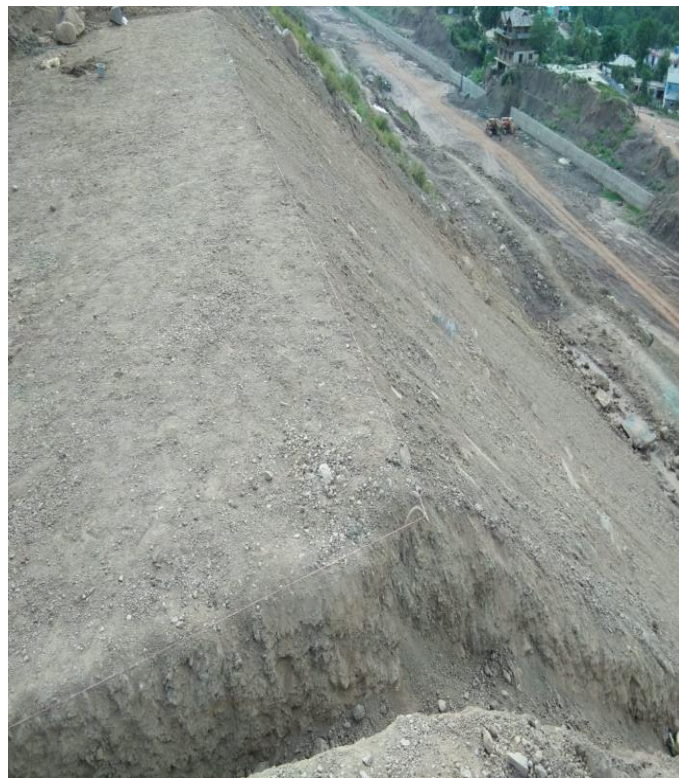
*After Site Preparation*

In July 2018 the work has been started to protect the slope from erosion of soil. First of all, we clear the surface from shrubs and fill the pit holes with soil and tried to even the slope and dressing was done. After that measured cut pieces laid on slope one by one with overlap of 100 mm between two pieces of CC then fixed it with the help of pegs having 1.5-2.5 meters length (On each 1m. interval) & 1.5" fully threaded round headed screws having washers. Two lines of screw are maintained on the overlap for better fixing result (each at 200mm distance in straight and 100mm in zigzag way). Weeping holes of PVC Pipes having 1.5 inch diameter also use to remove percolated water in soil so that it will decreases water pressure in inner portion. Insert ½. Concrete Canvas on both side drains with using pegs for fixing and do concreting on drain portion. Then cure it with water for one day having 2-3 hours intervals. The Project has completed one year of successful installation.

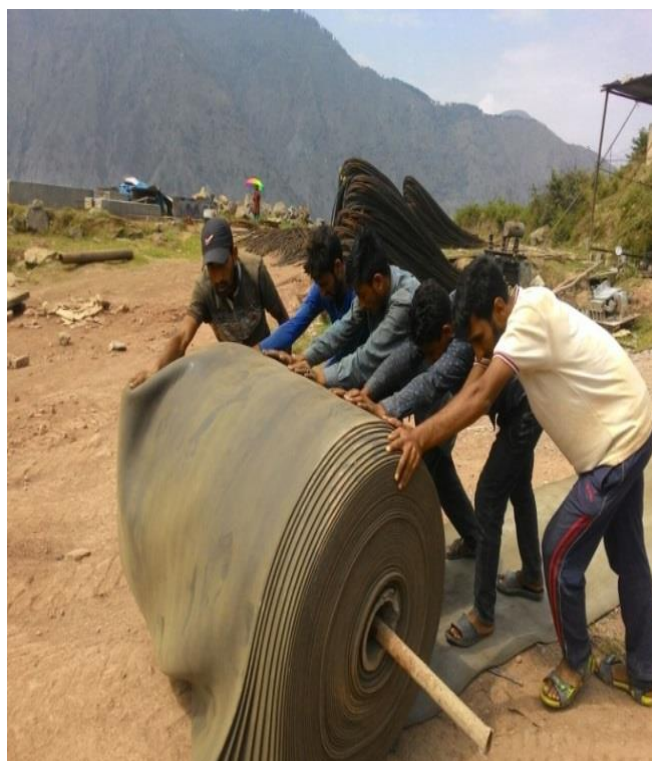
*Unrolling Bulk Rolls of CC8*

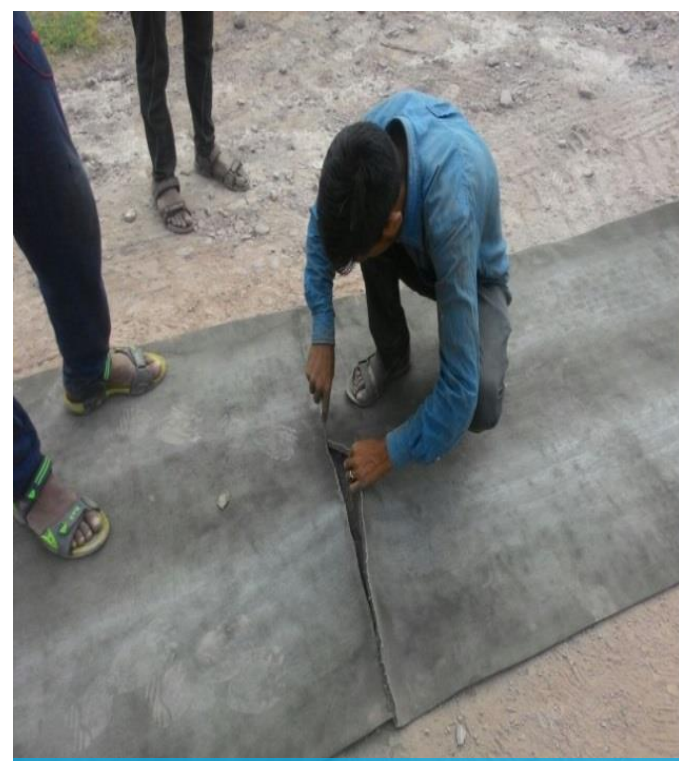
*Cutting as per measurements*

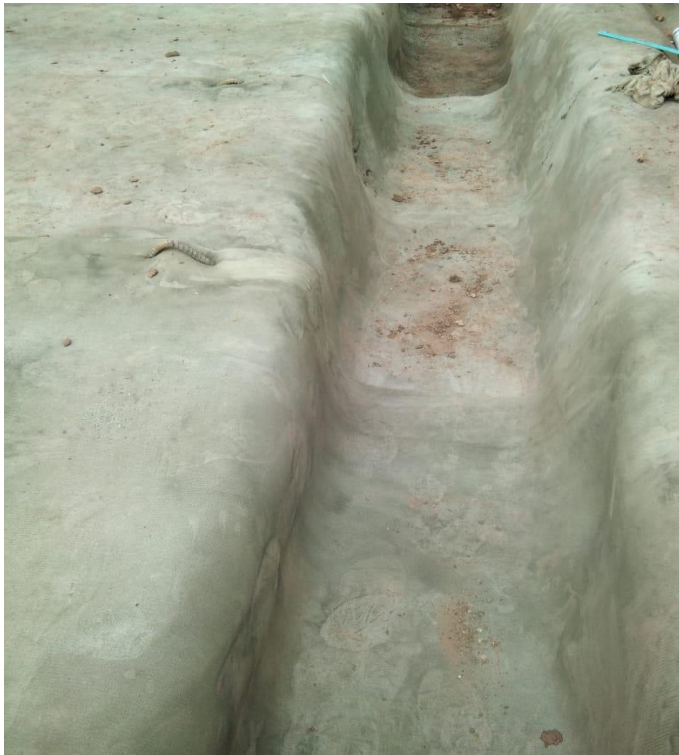
*Catch Water Drain on Berm*

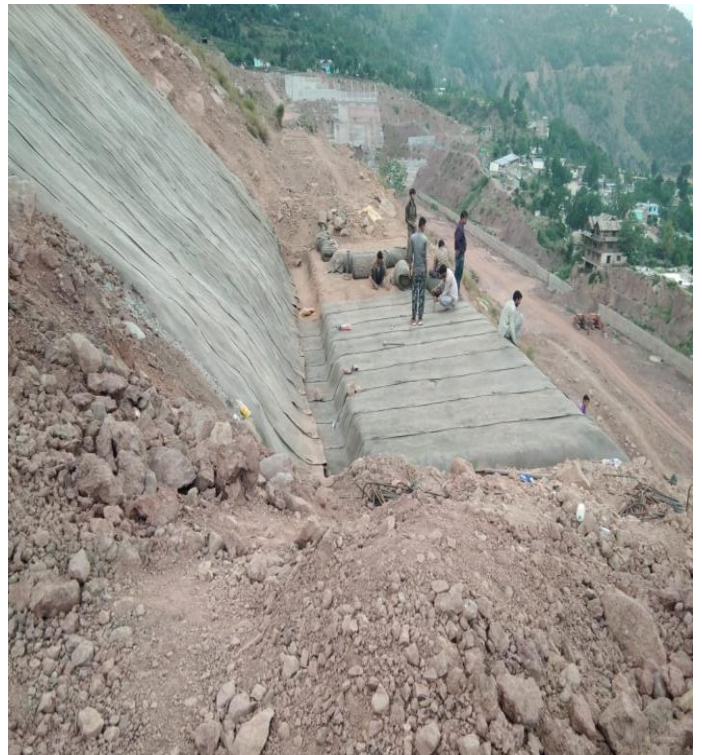
*Middle Berm View*

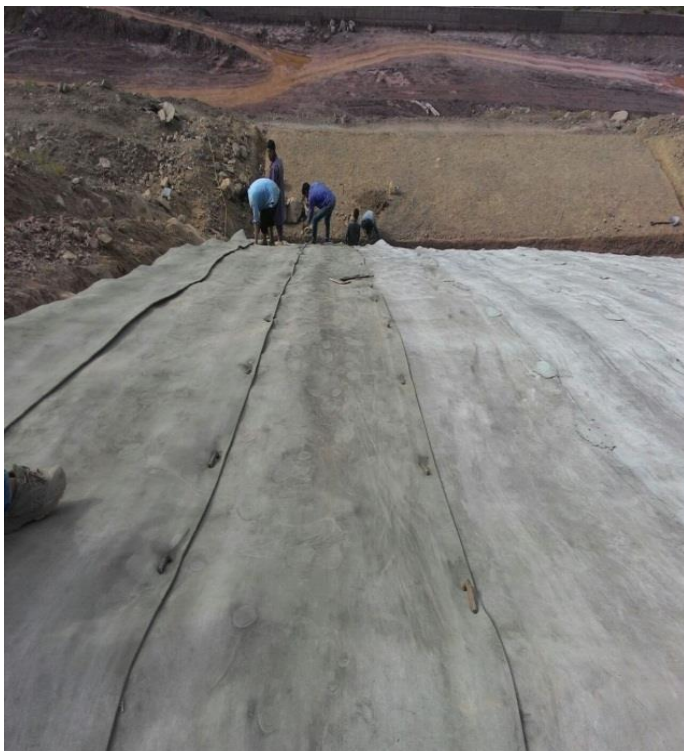
*Laying of CC8*

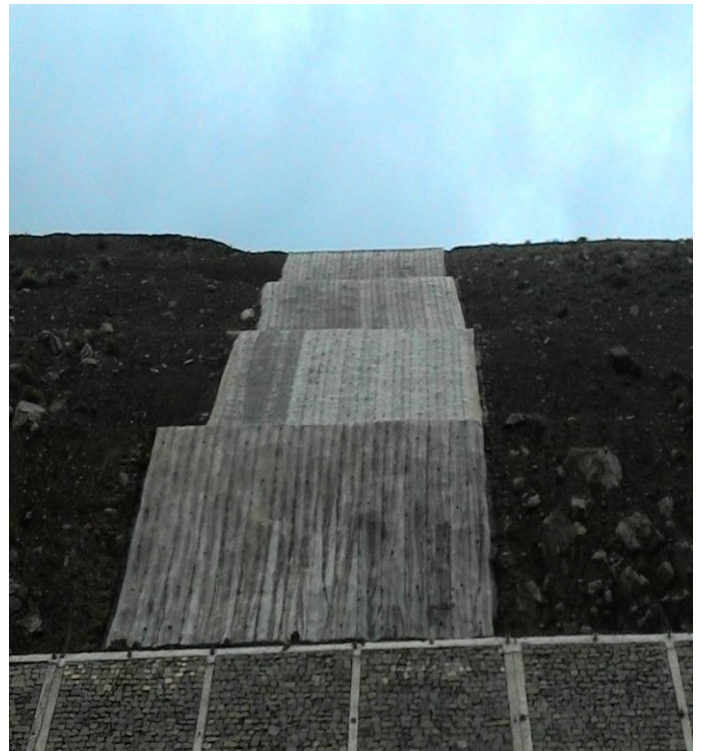
*Completed Installation*
