CONCRETE CANVAS

LHS JOINTS COVERING FROM INNER SIDE

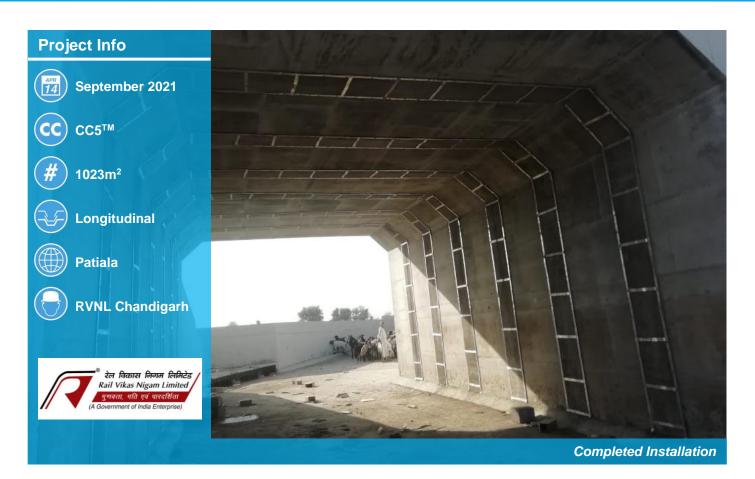
In September 2021, we started the work covering the LHS joints from inner side to stop water leakages to the subway. In rainy season, water was percolating through the gaps, thus it needs to be treated. RVNL Chandigarh allotted this work for covering joints with Concrete canvas to SSPL.

The installation team faces challenges like working at the height of 4m from the ground, restricted access and continuous train movements as well as vehicular movements. The silicon sealant used to stick the CC to the LHS blocks were not sticking and due to continuous vibrations from rain movement we need to use Hilti nails as well.

Currently, out of installation of 1023sqm, 245sqm is completed for LC No 5, 12 & 13 to cover joints of 12-16m internal dimensions of blocks and retaining wall joints. The team did the first work with some difficulties in only 4 days from start to end. After which the remaining works are done faster due to labours training. More LCs are in preparation and we expected to resume the work in January 2022.
