## Project Info

CC5™

Shivrampally

RVNL Hyderabad

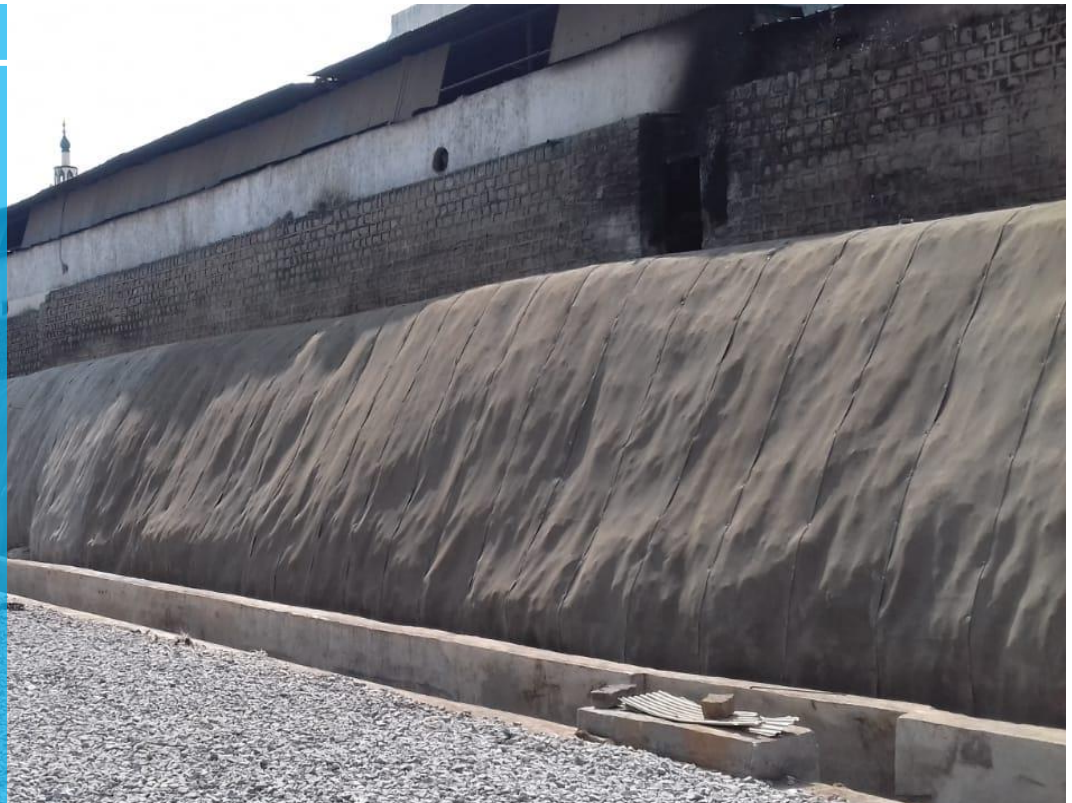
Installation Completion Photo

After visiting the site, the work of new line is going under process and the slope near the planned alignment of new railway track is prone to erosion due to vibrational movement of train. Also the drain at the side of line is getting blocked due to soil gets directly in drain so to prevent the surface erosion of the sited slope, RVNL has decided to use concrete canvas 5mm thick immediately for fast work and long term solution.

In January 2019, the work has been started to protect the slope from erosion of soil. First of all we clear the surface from shrubs and fill the pit holes with soil and tried to even the slope. On the top of the slope a drain was digged, cut piece laid on slope one by one with overlap of 100 mm between two cut pieces, dressing was done, and then fixed it with the help of pegs. Then Clean the overlap portion from dust and dry cement and used cement based sealant (to stick overlap) then tight 1" fully threaded screw having washers on the overlap for better fixing result. Then cure it with water for one day having 2-3 hours intervals. Above project completed having 400sqm area in 25 working days with 15 to 20 labor's team. The work is completed in 20 days only including heavy site preparation.

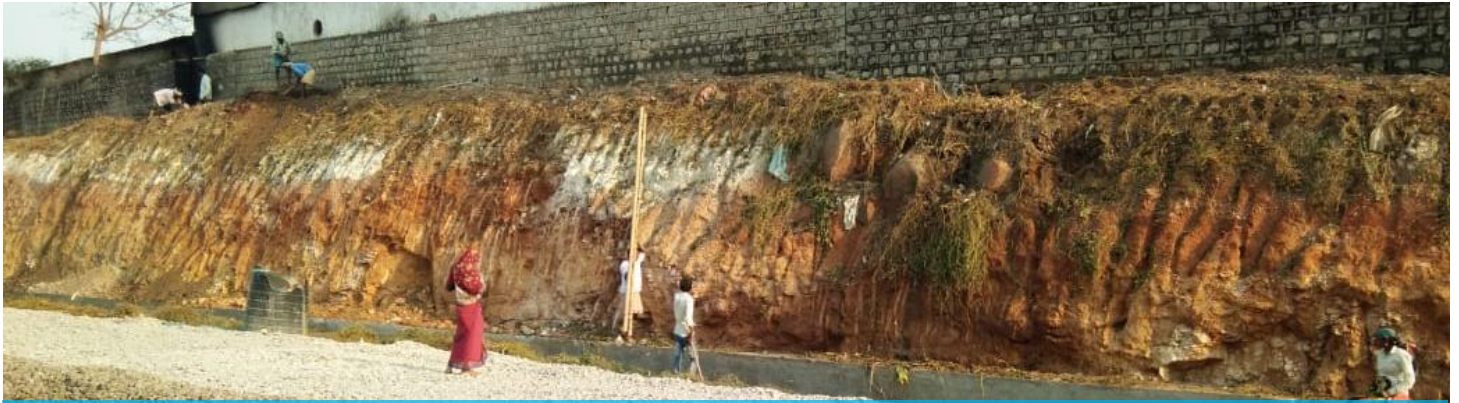
Site Before Preparation

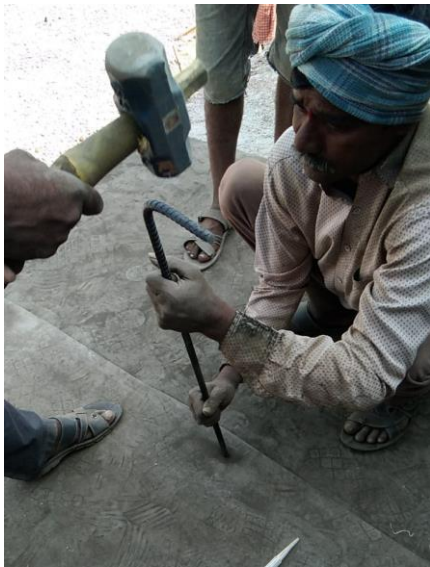
Pegging

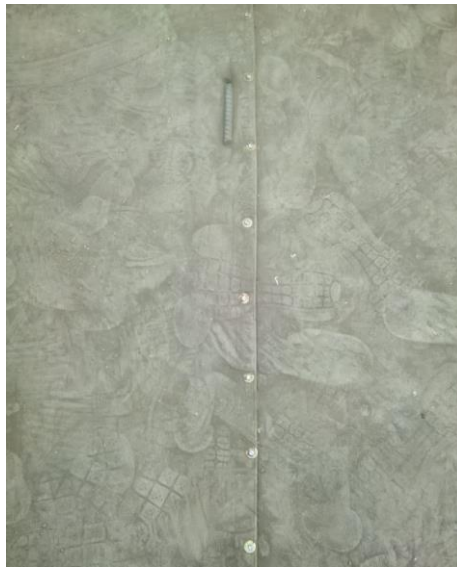
Screwing

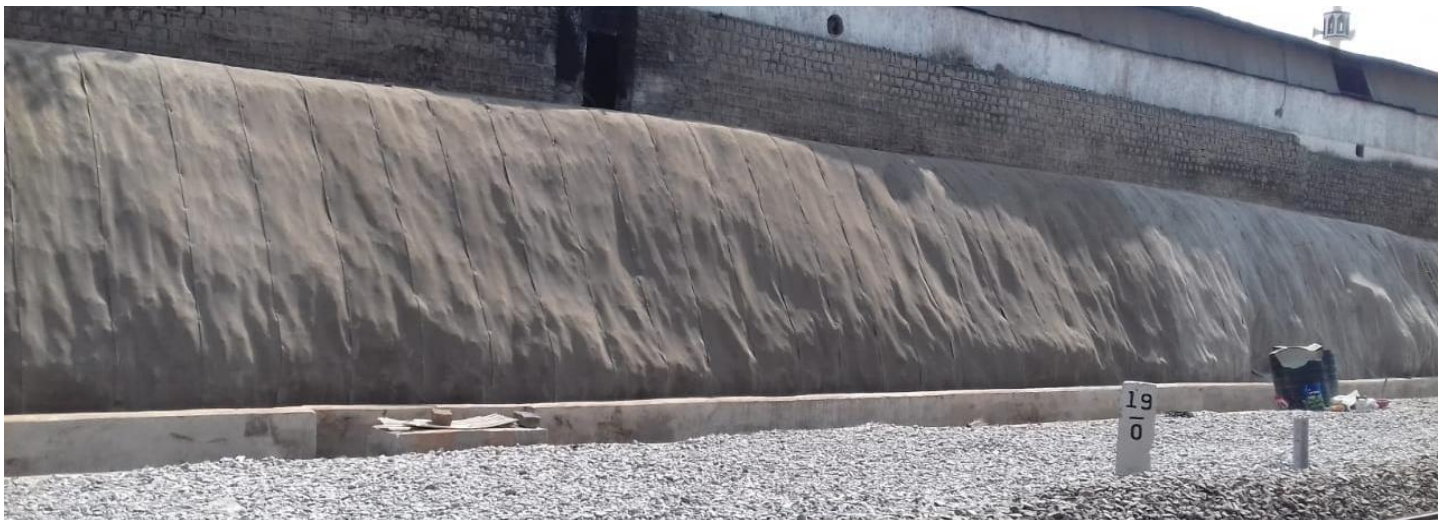
Site after Installation
