Project Info

CC5™

Gosekhurd

Vidarbha Irrigation

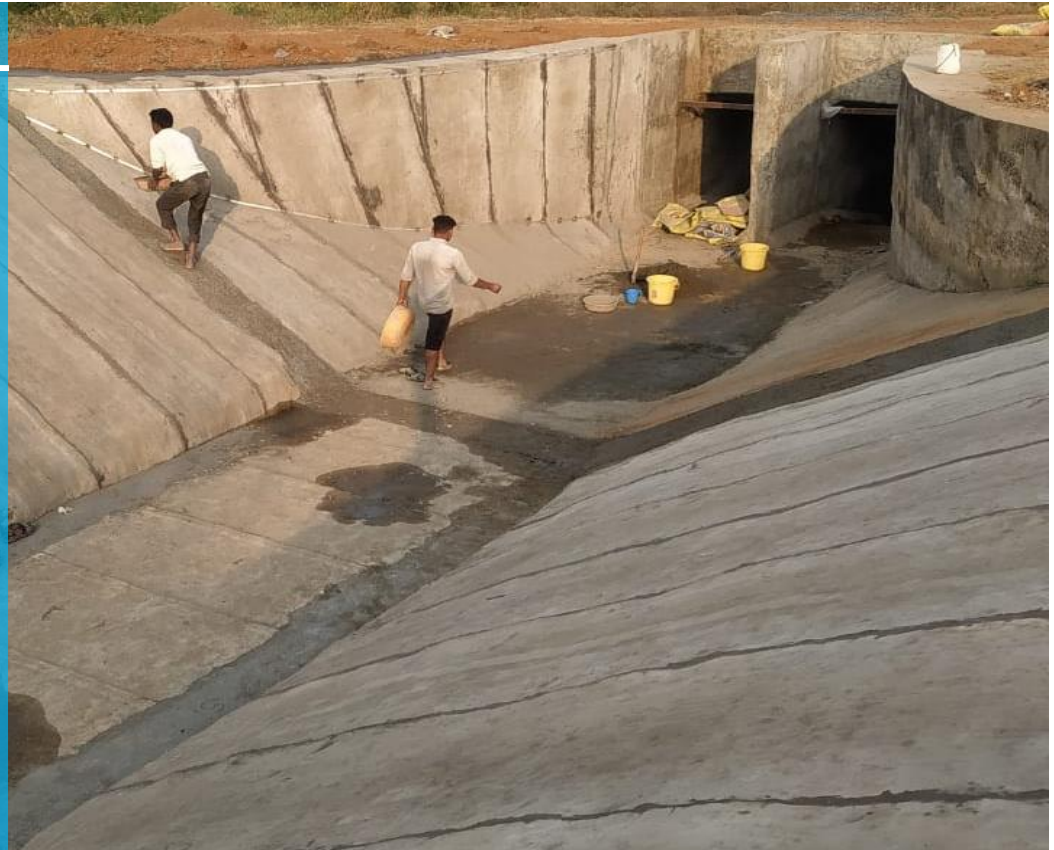
Near completion photo

In first week of December, 2021, we started the work of Bank Protection at Gosekhurd left bank canal near Konda. Concrete Canvas 5mm thick was used to cover the 25m initial length of canal beside sluice gate on both side slopes.

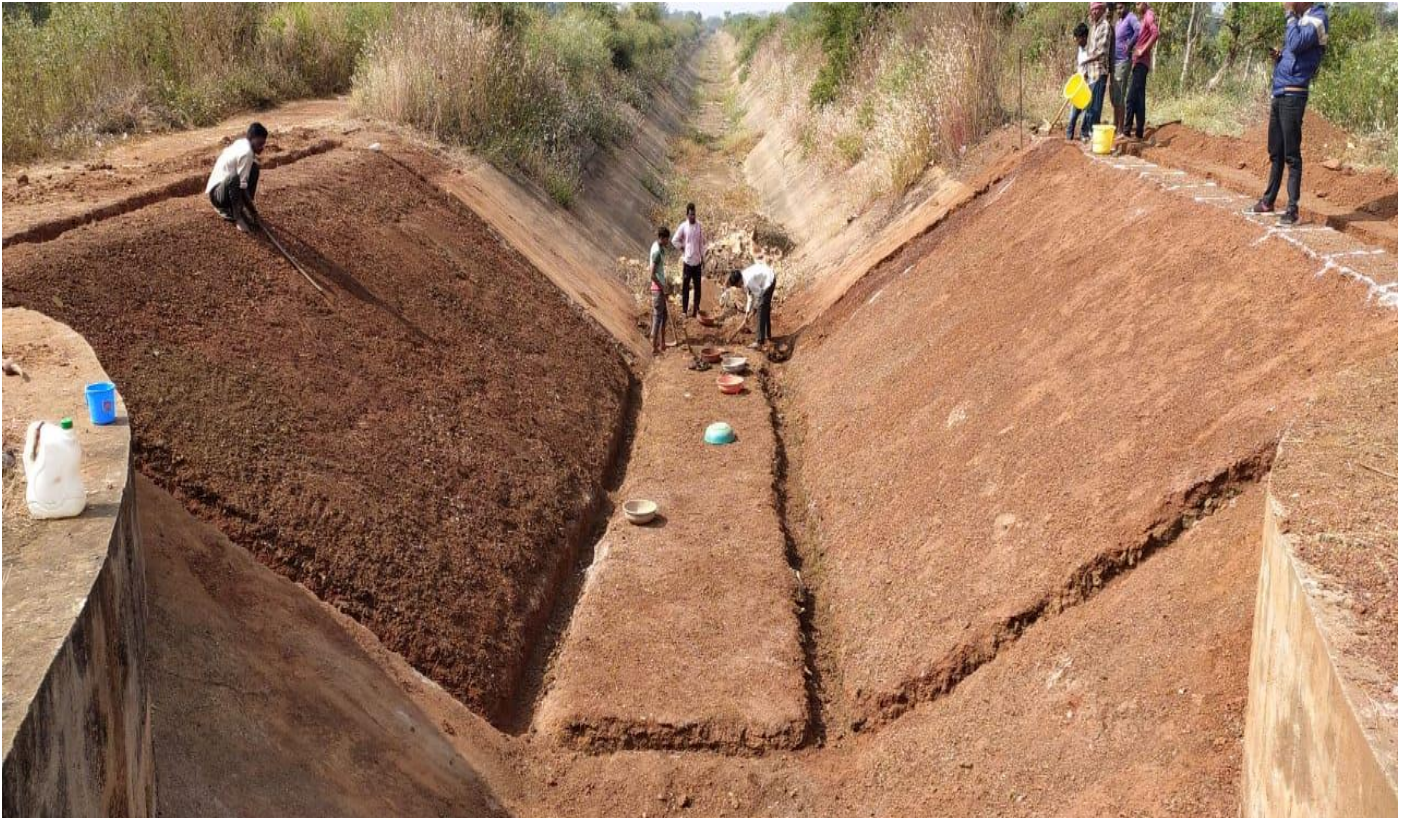
Preparation of canal

The project came with several challenges, including slope cutting, matching key level to achieve uniformity in work, mud & rain water collected on bed of canal, etc. The working area was muddy and rain cuts occurs due to every night rain. The installation was carried out stepwise precisely to avoid water ingress inside CC overlaps. First of all, we prepare the slopes at required dimensions and levels as of old canal concrete lining, then CC5 was laid by fixing steel pegs at excavated anchor trenches at top & bottom. The overlaps are by thermal welding by Leister Automatic tool for achieving maximum impermeability and sealant coat also given on edges of overlapping for additional protection. Concreting at trenches are important to hold the CC ends properly.

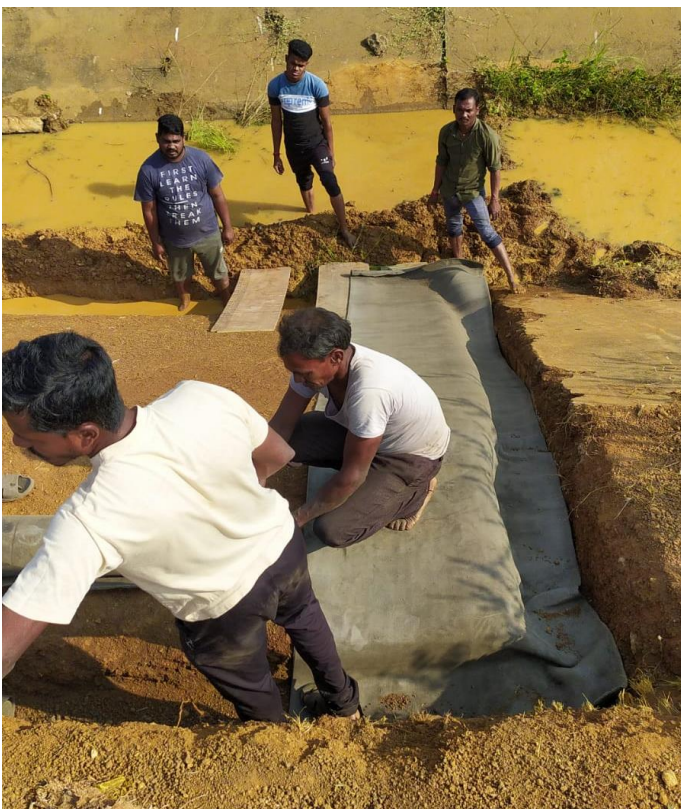
Laying of CC patches

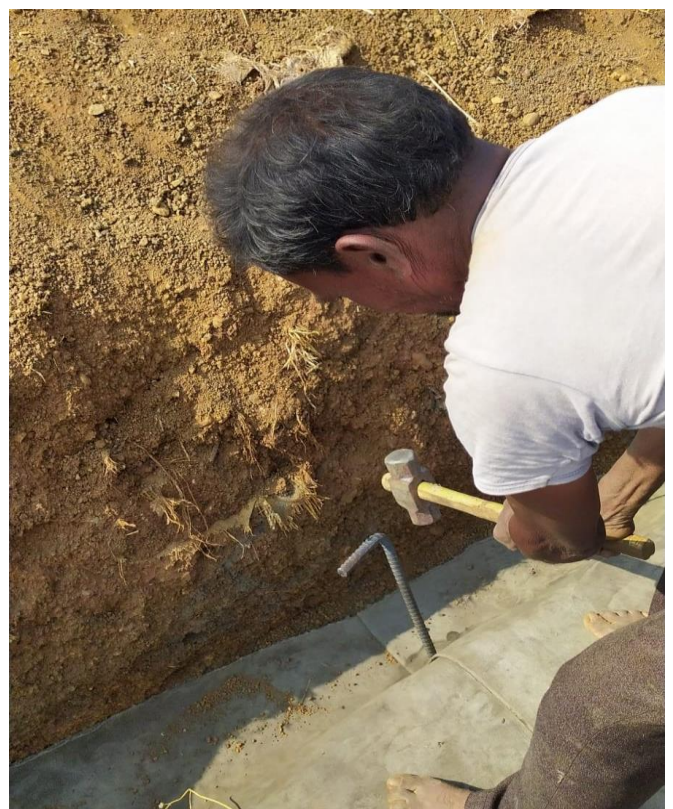
Fixing inside anchor trench

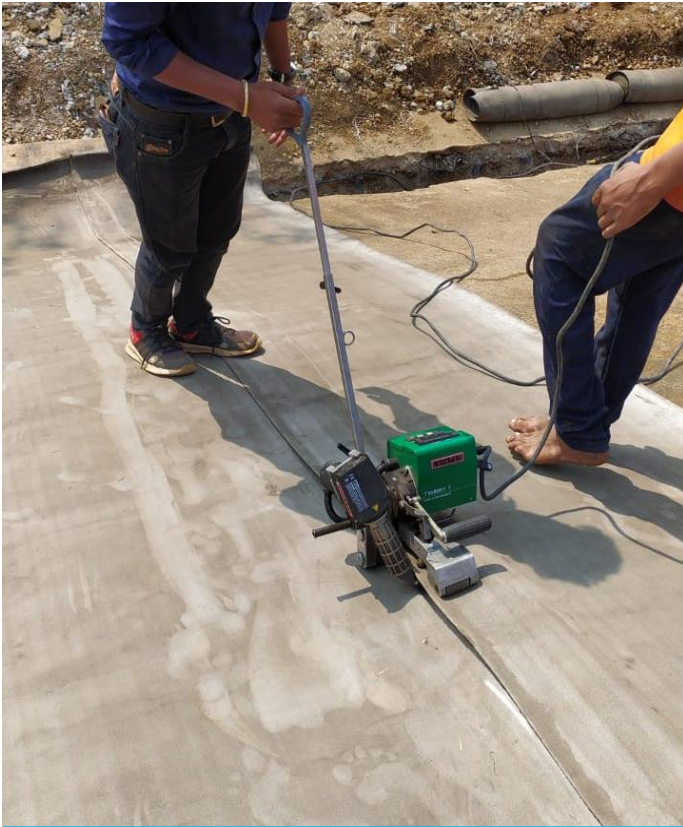
Jointing of overlap by thermal welding method

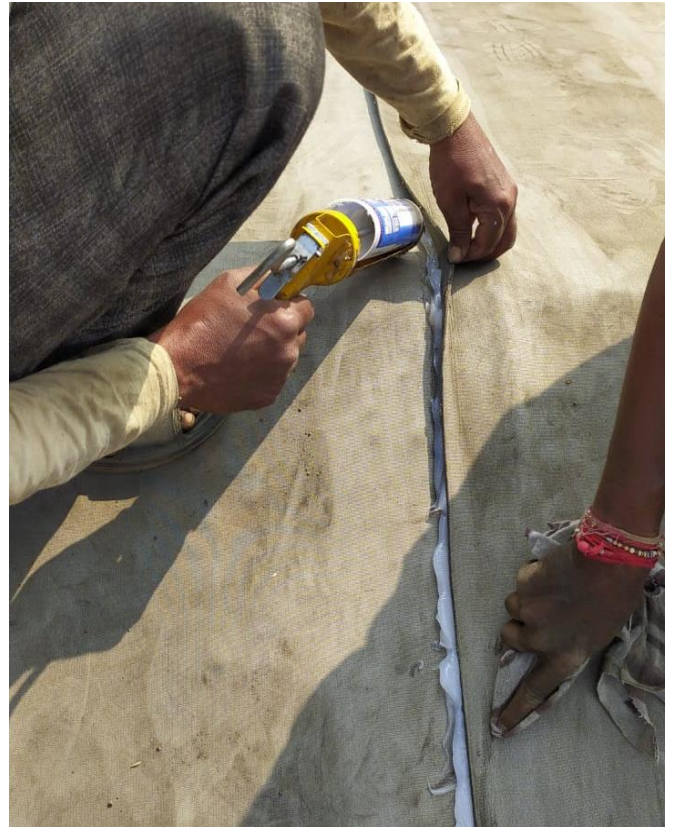
Edge sealing with silicon sealant

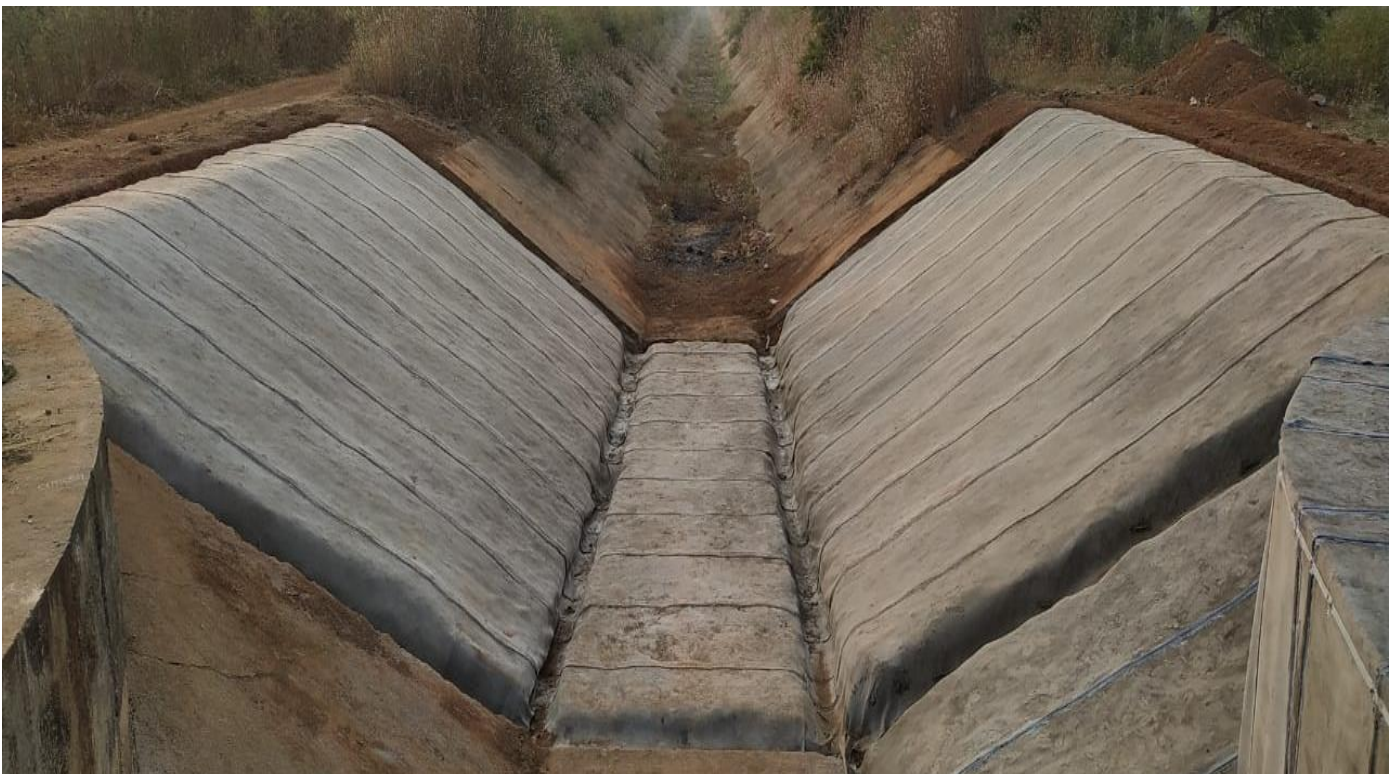
Completely lined canal with concrete canvas installation done at Location 1
