## CONCRETE CANVAS

### LHS JOINTS COVERING FROM INNER SIDE

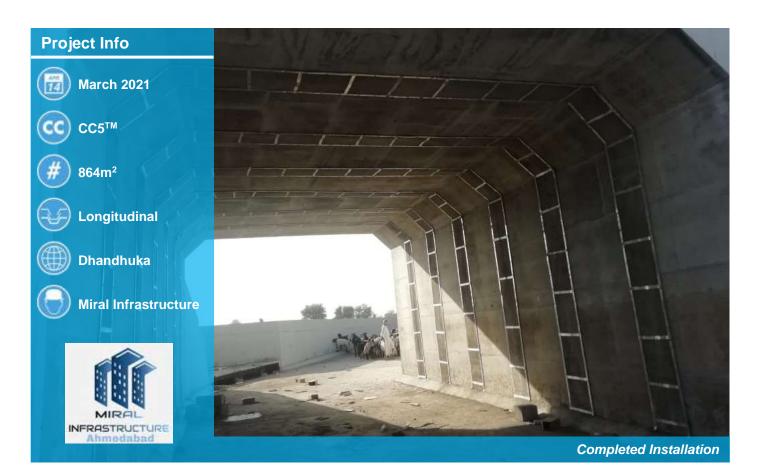
On 11<sup>th</sup> March 2021, we have started the work covering the LHS joints from inner side to stop water leakages to the subway. In rainy season, water were percolating through the gaps, thus it needs to be treated. RVNL Ahmedabad allotted this work for covering joints with Concrete canvas to SSPL under Miral Infrastructures Ltd.

The installation team faces challenges like working at the height of 4m from the ground, restricted access and continuous train movements as well as vehicular movements. The silicon sealant used to stick the CC to the LHS blocks were not sticking and due to continuous vibrations from rain movement we need to use Hilti nails as well.

In total, 864sqm of CC5 were used to cover 14-16 LHS ranging from joints of 12-16m internal dimensions of blocks. The team did the first work with some difficulties in only 4 days from start to end. After which the remaining works are done faster due to labours training. Complete Project done in 2 weeks' time with 4 engineers and 16 labours team.
