## WATERBODY REMEDIATION

Concrete Canvas 5mm was used to line concrete water body structure constructed for drinking water storage for animals inside Zoo Area at Sanjay Gandhi National Park, Borivali, Mumbai.

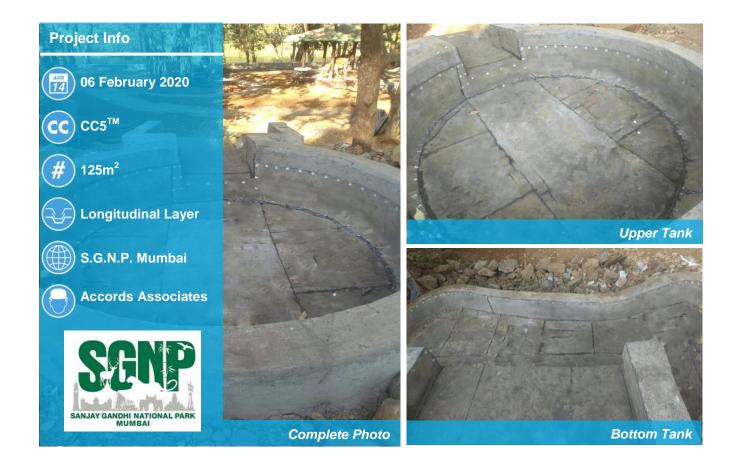
As per drawing provided by the client, the work was done in one working day with team of 8 labours and 1 supervisor. We simply lay the concrete canvas layers side-by-side and stick it with silicon sealant adhesive and at the end corners of work we fixed with Hilti GX3 nailing machine. The work was allotted to M/S. Sanbros Spares Pvt. Ltd. Nagpur under M/S. Accords Associates, Mumbai & Public Works Department. In total 50sqm of CC5 was used to get done this work. Concrete Canvas having low washout rate & water impermeable saves the water seepage to ground and do not harm water content with adding impurities & without changing pH value of water.

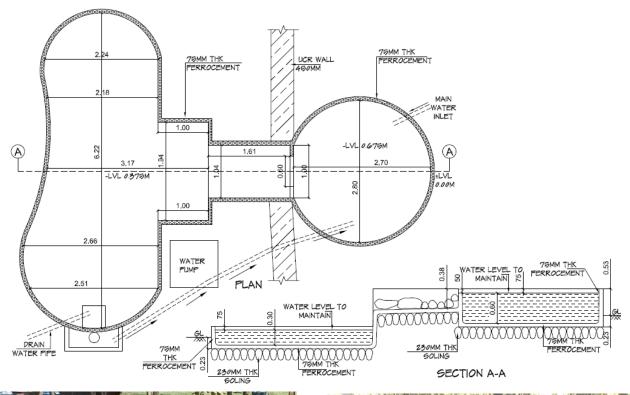
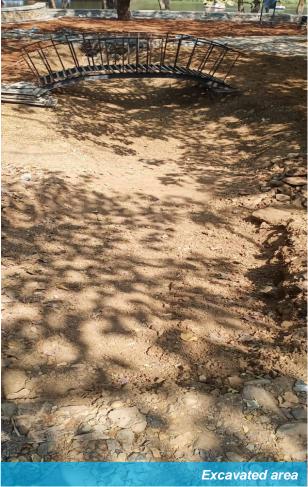
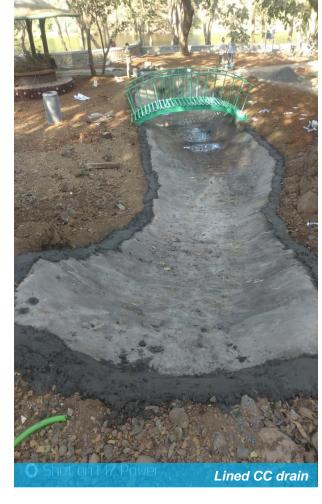
In same area, we have done another work of Drain under same contractor M/S Accord Associates. In total 75sqm of Concrete canvas 5mm was used to line the excavated drain portion in 1 day. Both works done in 2 days, with using 125sqm of Concrete Canvas 5mm thick. Following are drawings provided by M/S Accords Associates with working photos of installation.
