We stated the trail work of Yard Line application (Washing Appron) to protect seepages through the track. Due to continuous movement of train the concreting below the track is getting cracks. The jointing between the concrete sleepers and existing concreting gets bigger and bigger each day. After some time the water also passes through it and create dampness to the area nearby. To avoid any major incidents the authorities decided to use Concrete Canvas 8mm thick in a trail order to see whether is works or not.

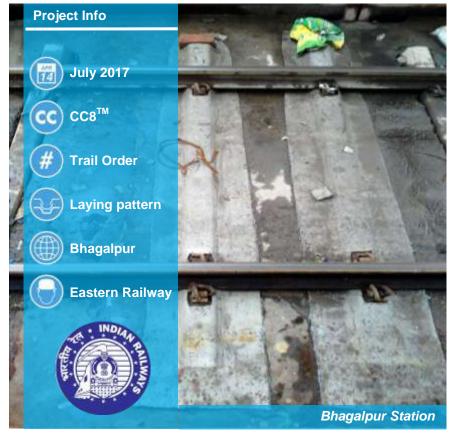
This project comes with several challenges such as train movement, limited work time and lifting of track etc. Once the track was lifted we mark the outlines of area to be covered, then remove water from the gaps formed. We clean the total area before installation and fix the CC8 with silicon sealant.

The Concrete Canvas serves its purpose and authorities are pleased with its performance. The authority inspects the work on 14th July 2017 and confirms the okayness of the work. The performance certificate issued immediately by the Sr. Sectional Engineer, P-Way.
